# A CRITICAL REVIEW ON PREVENTING RIVER BANK EROSION BY USING PLANT AND VEGETATION

**Prof. Arup Kumar Sarma**  
*B.P.Chaliha Chair Professor for Water Resources*  
Civil Engineering Department  
**Indian Institute of Technology Guwahati**

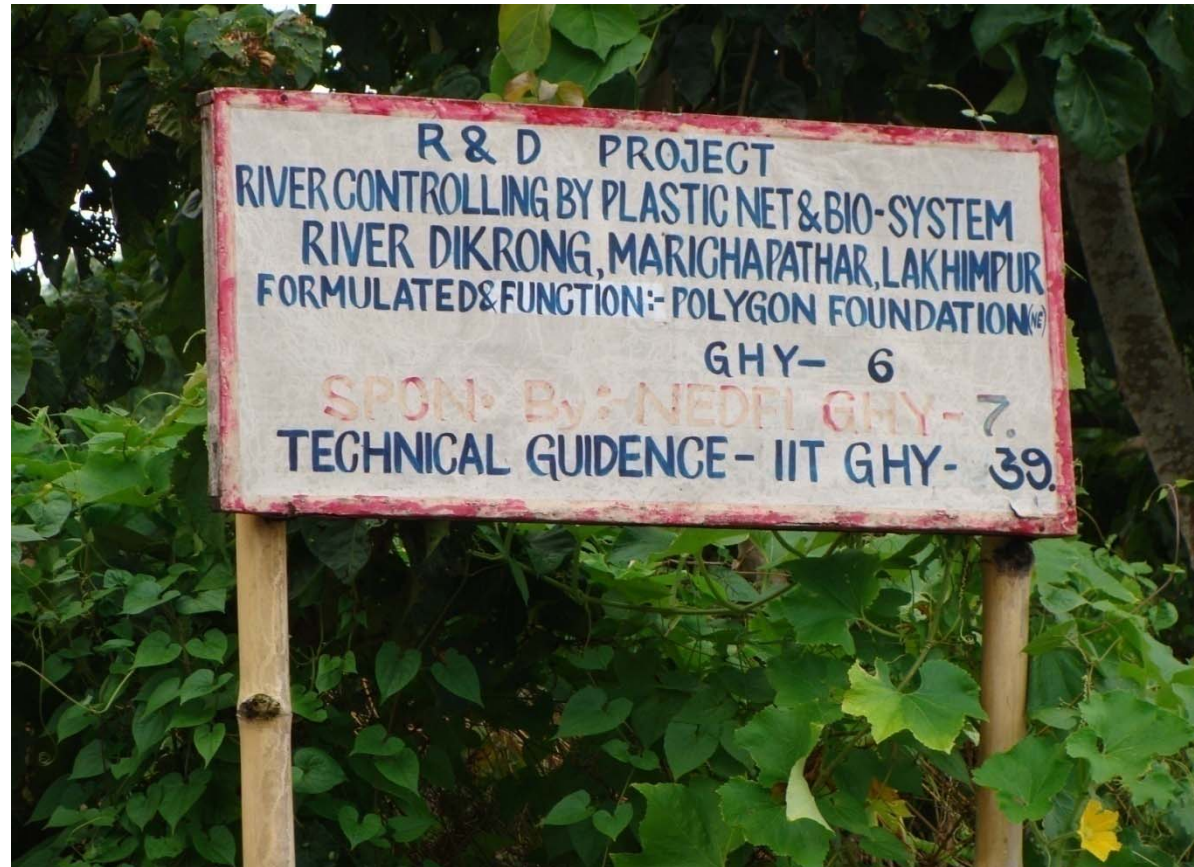
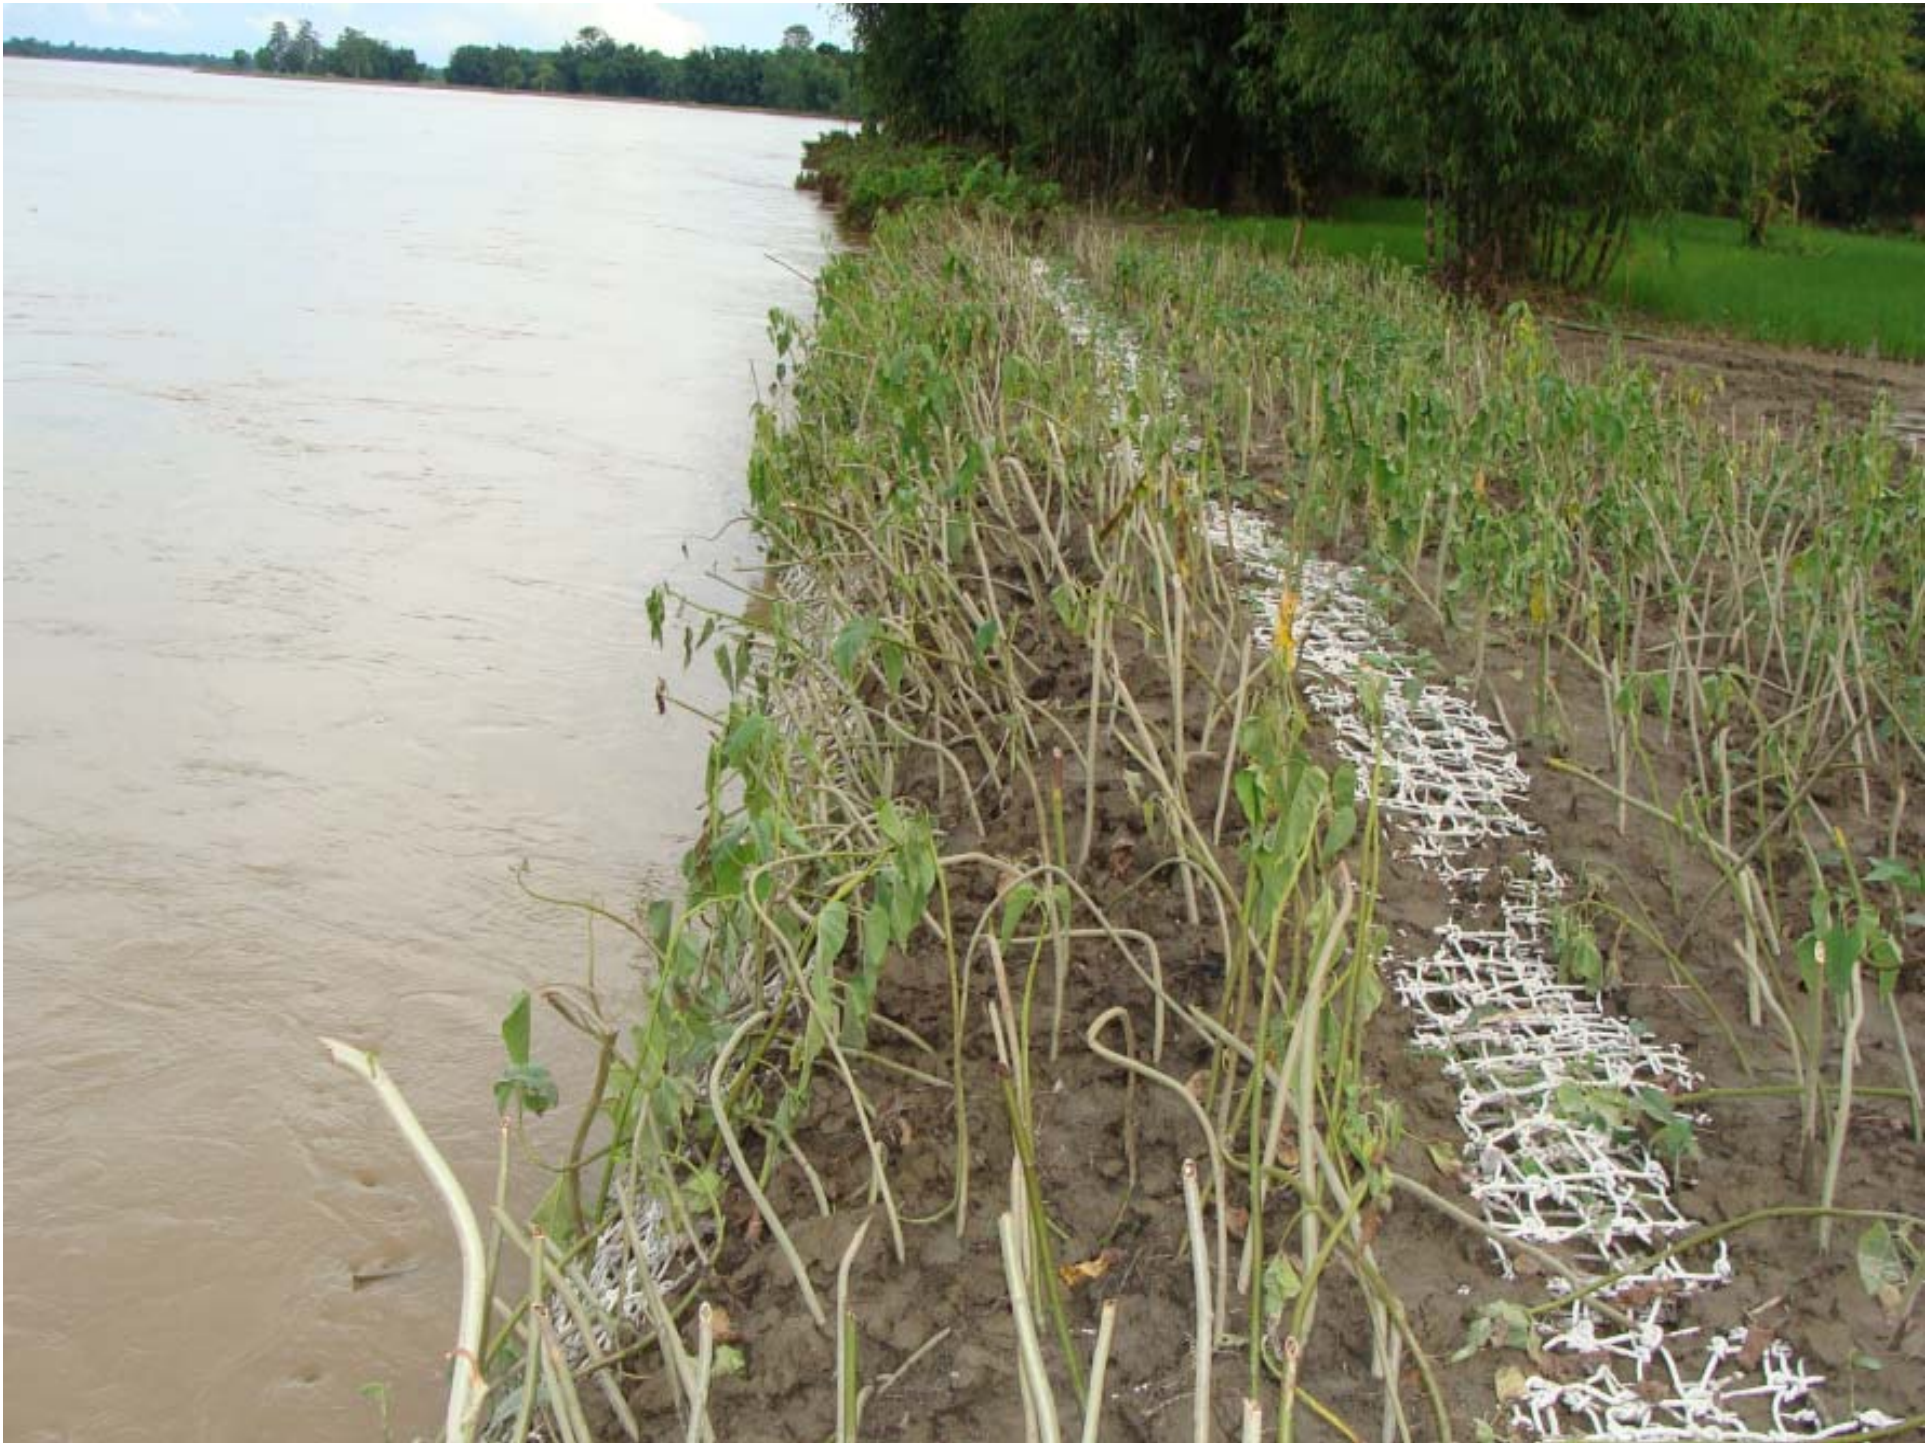
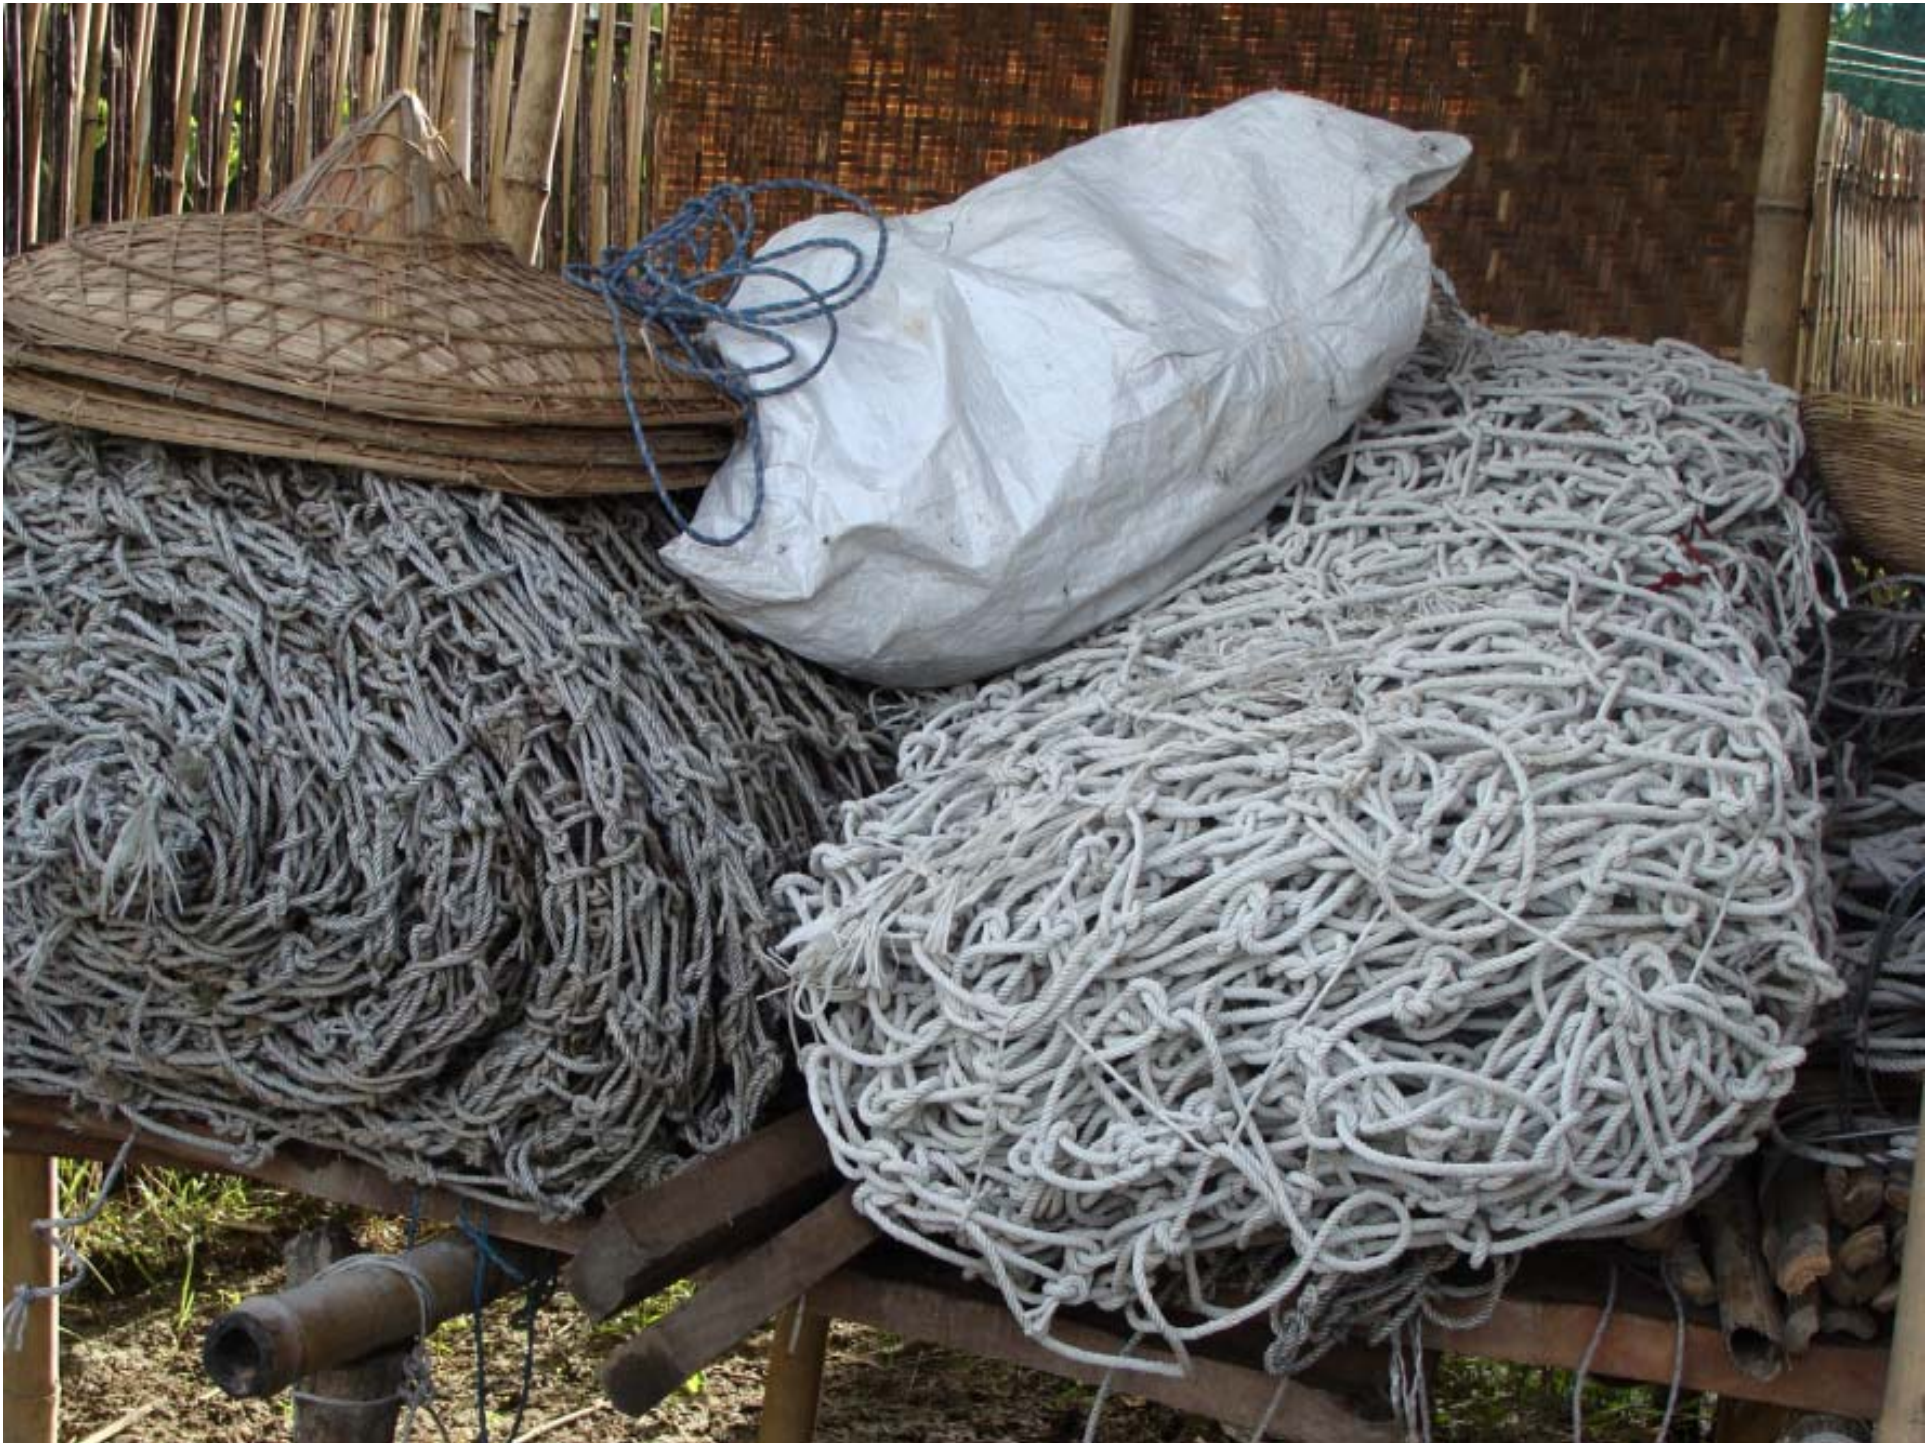
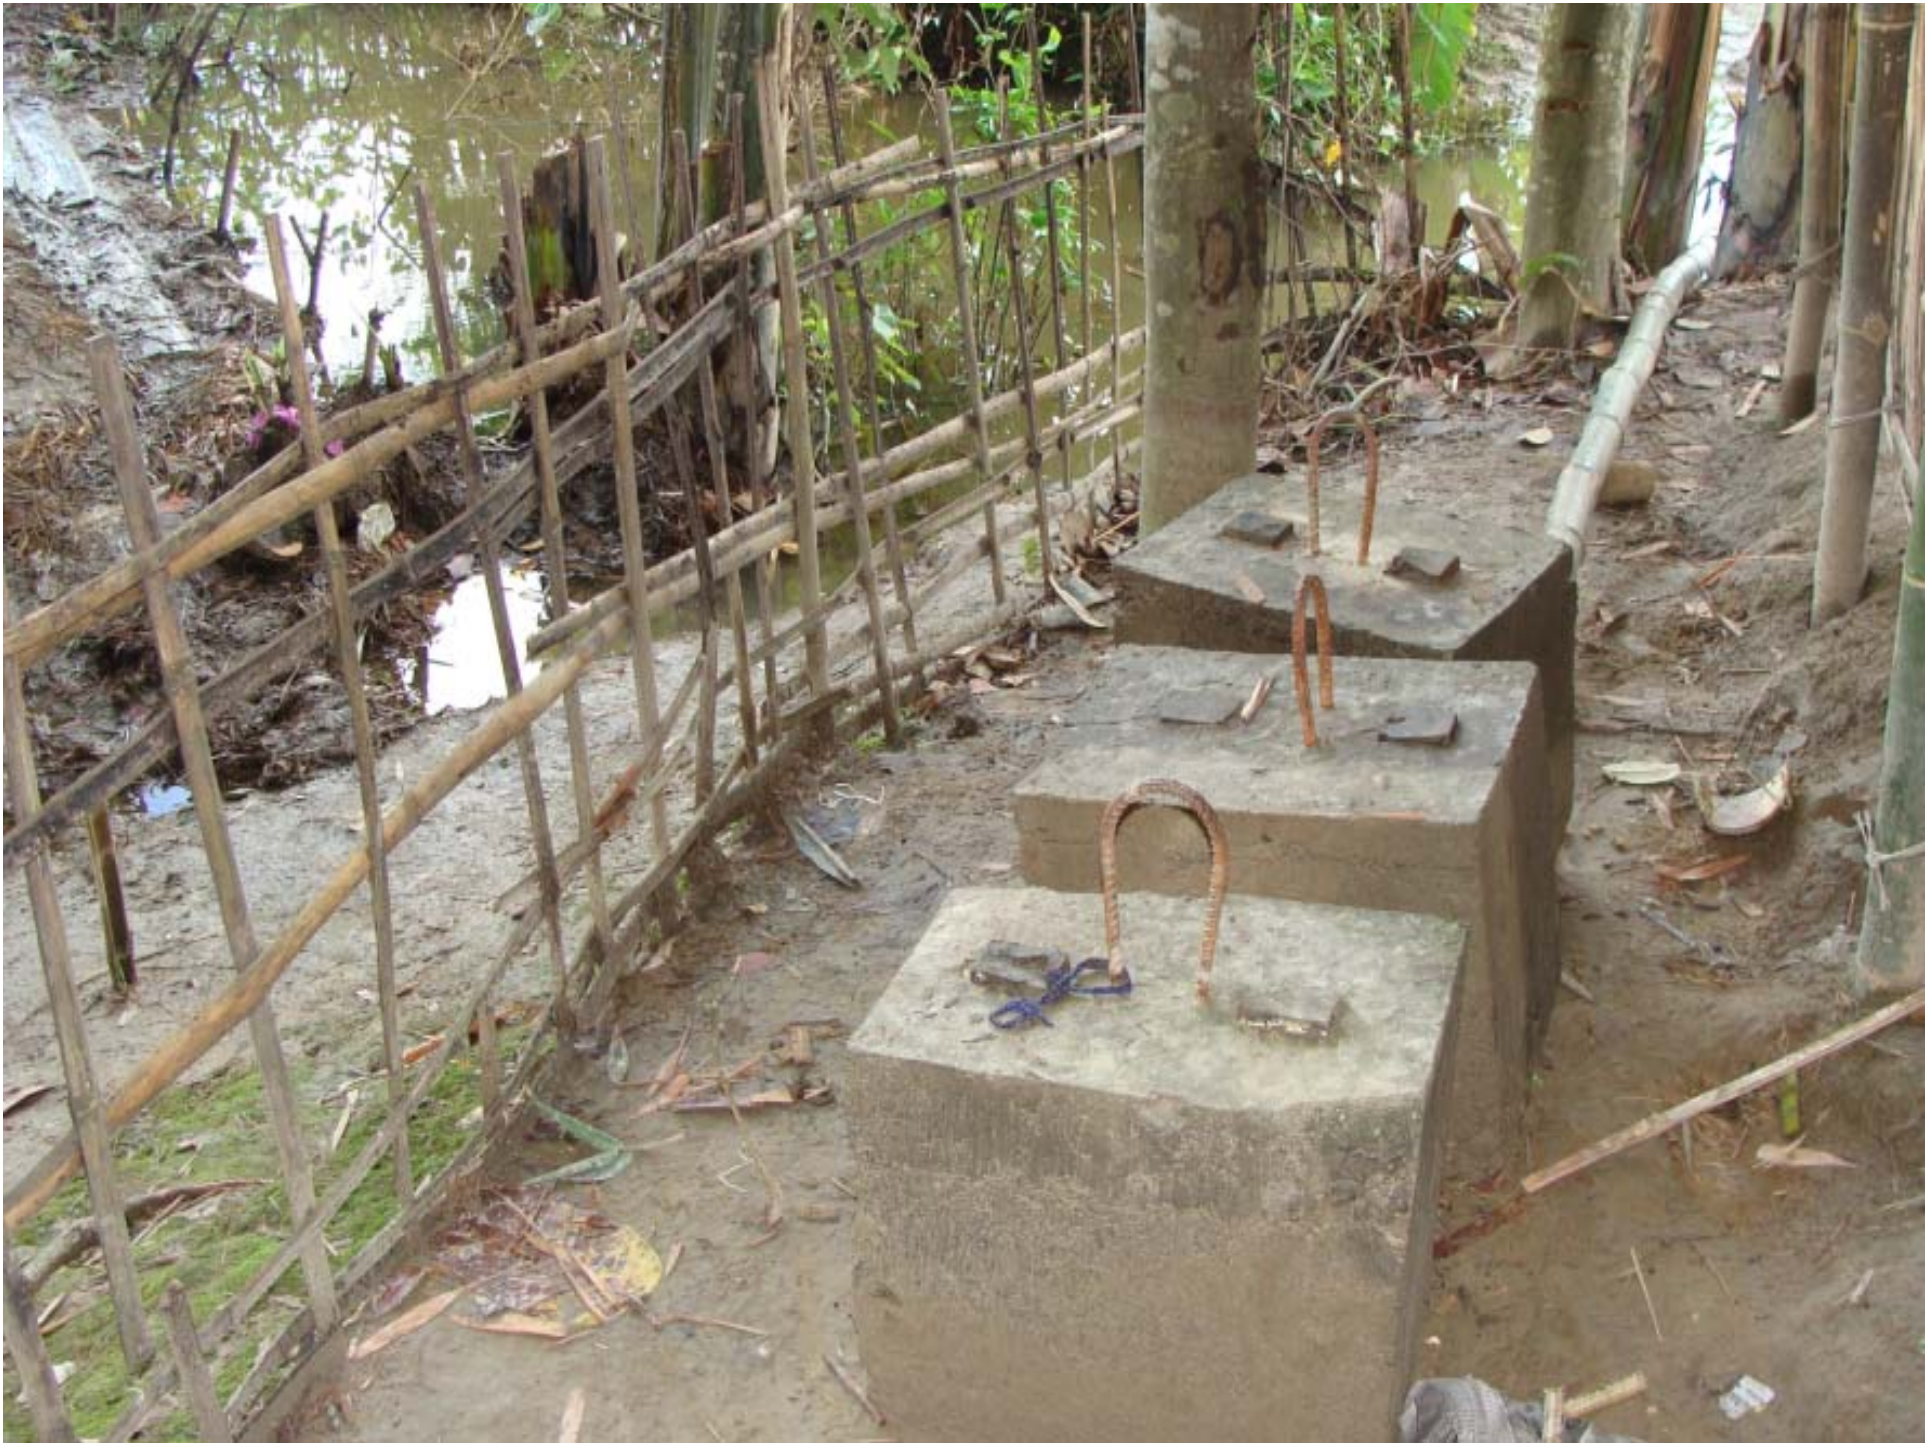
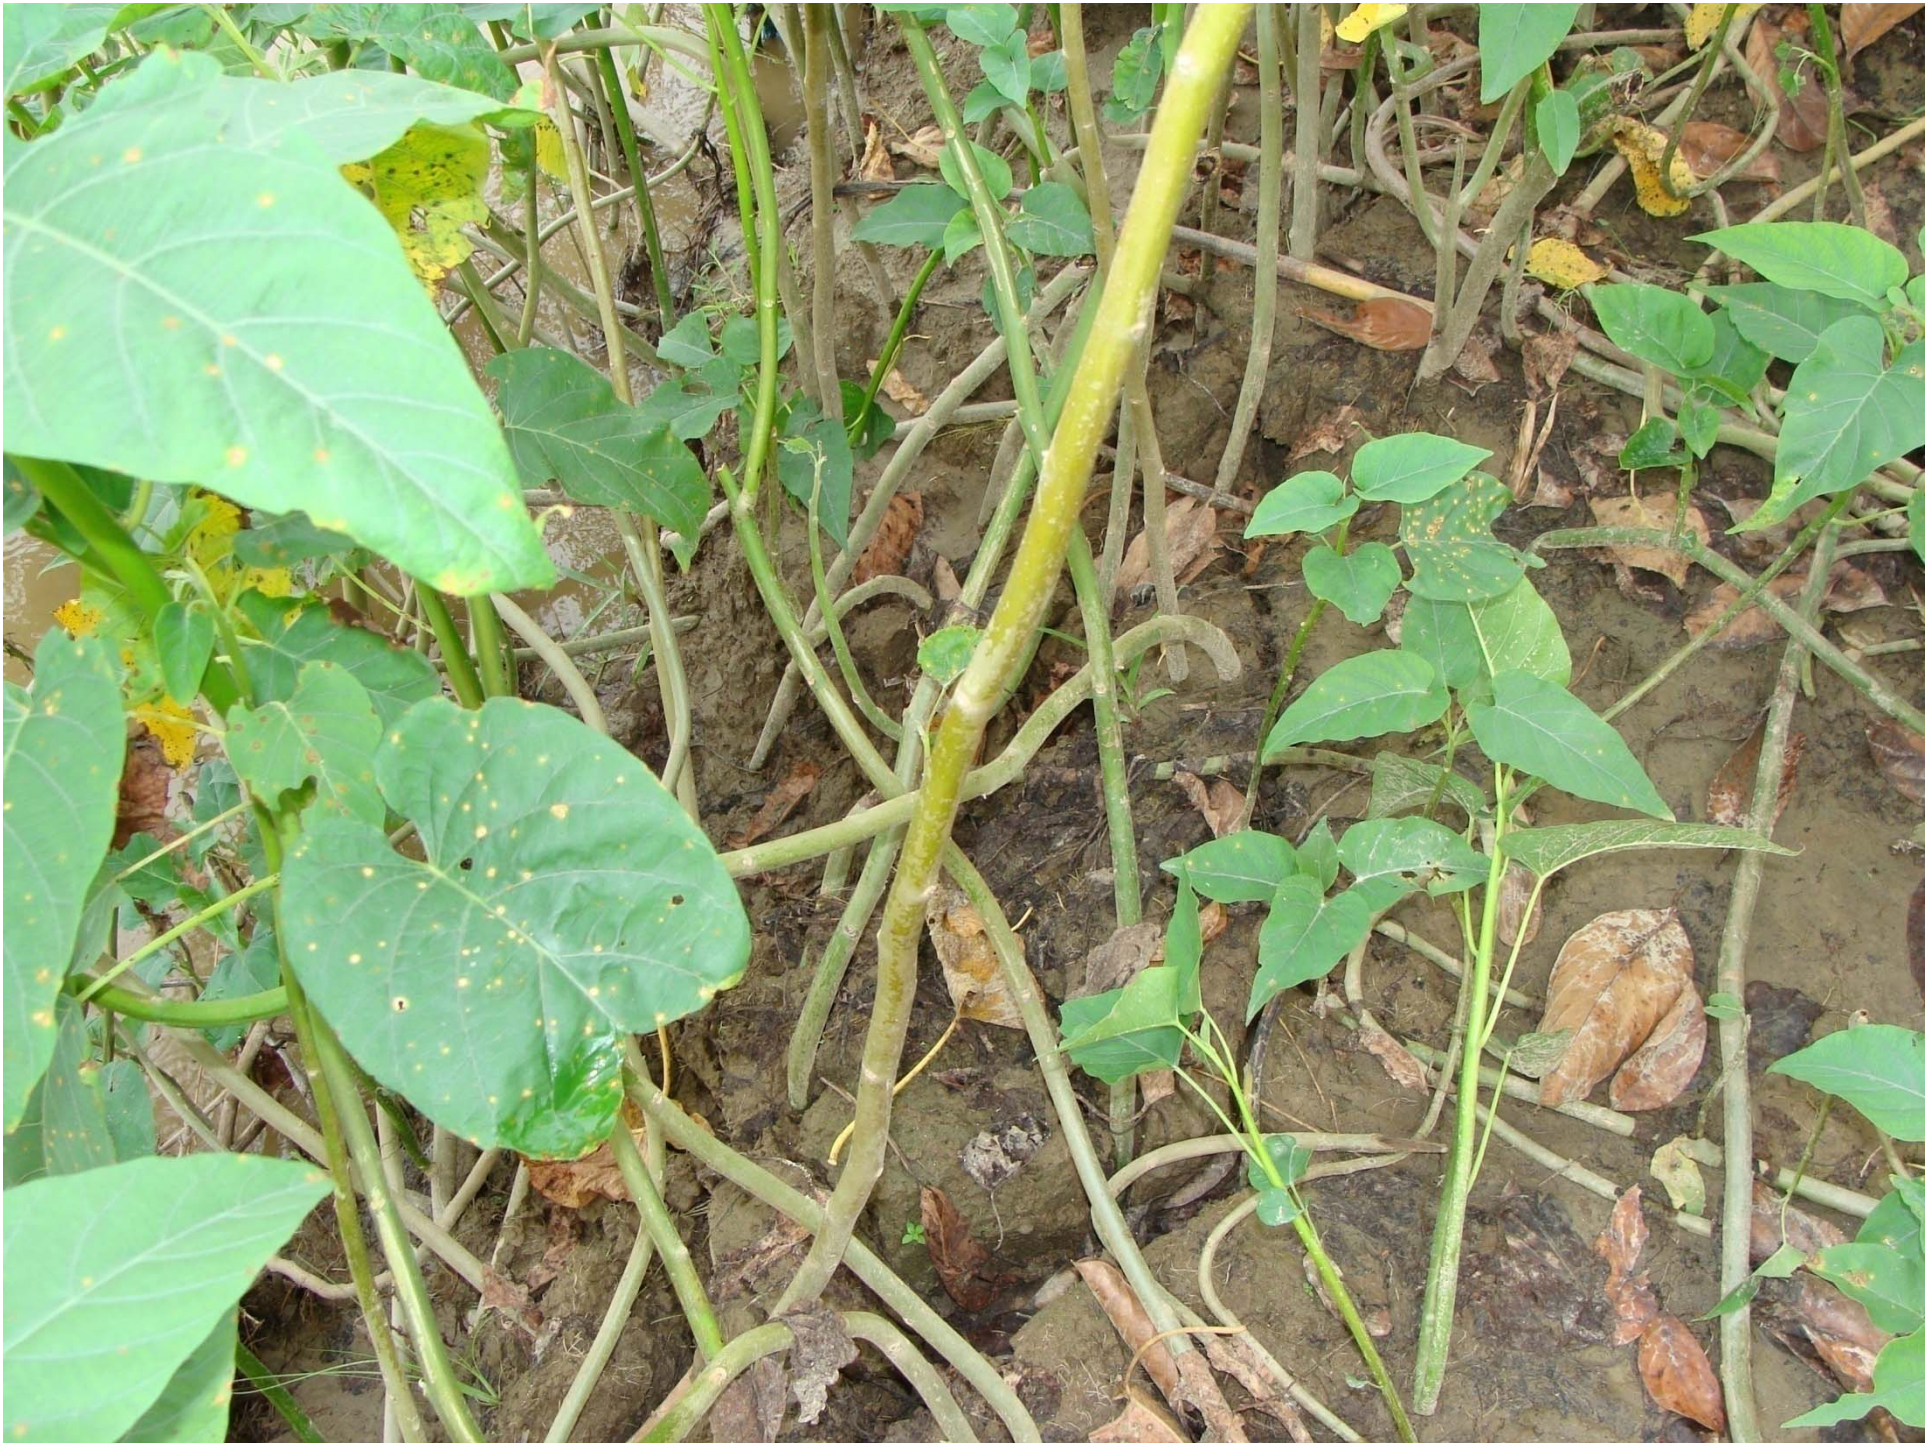
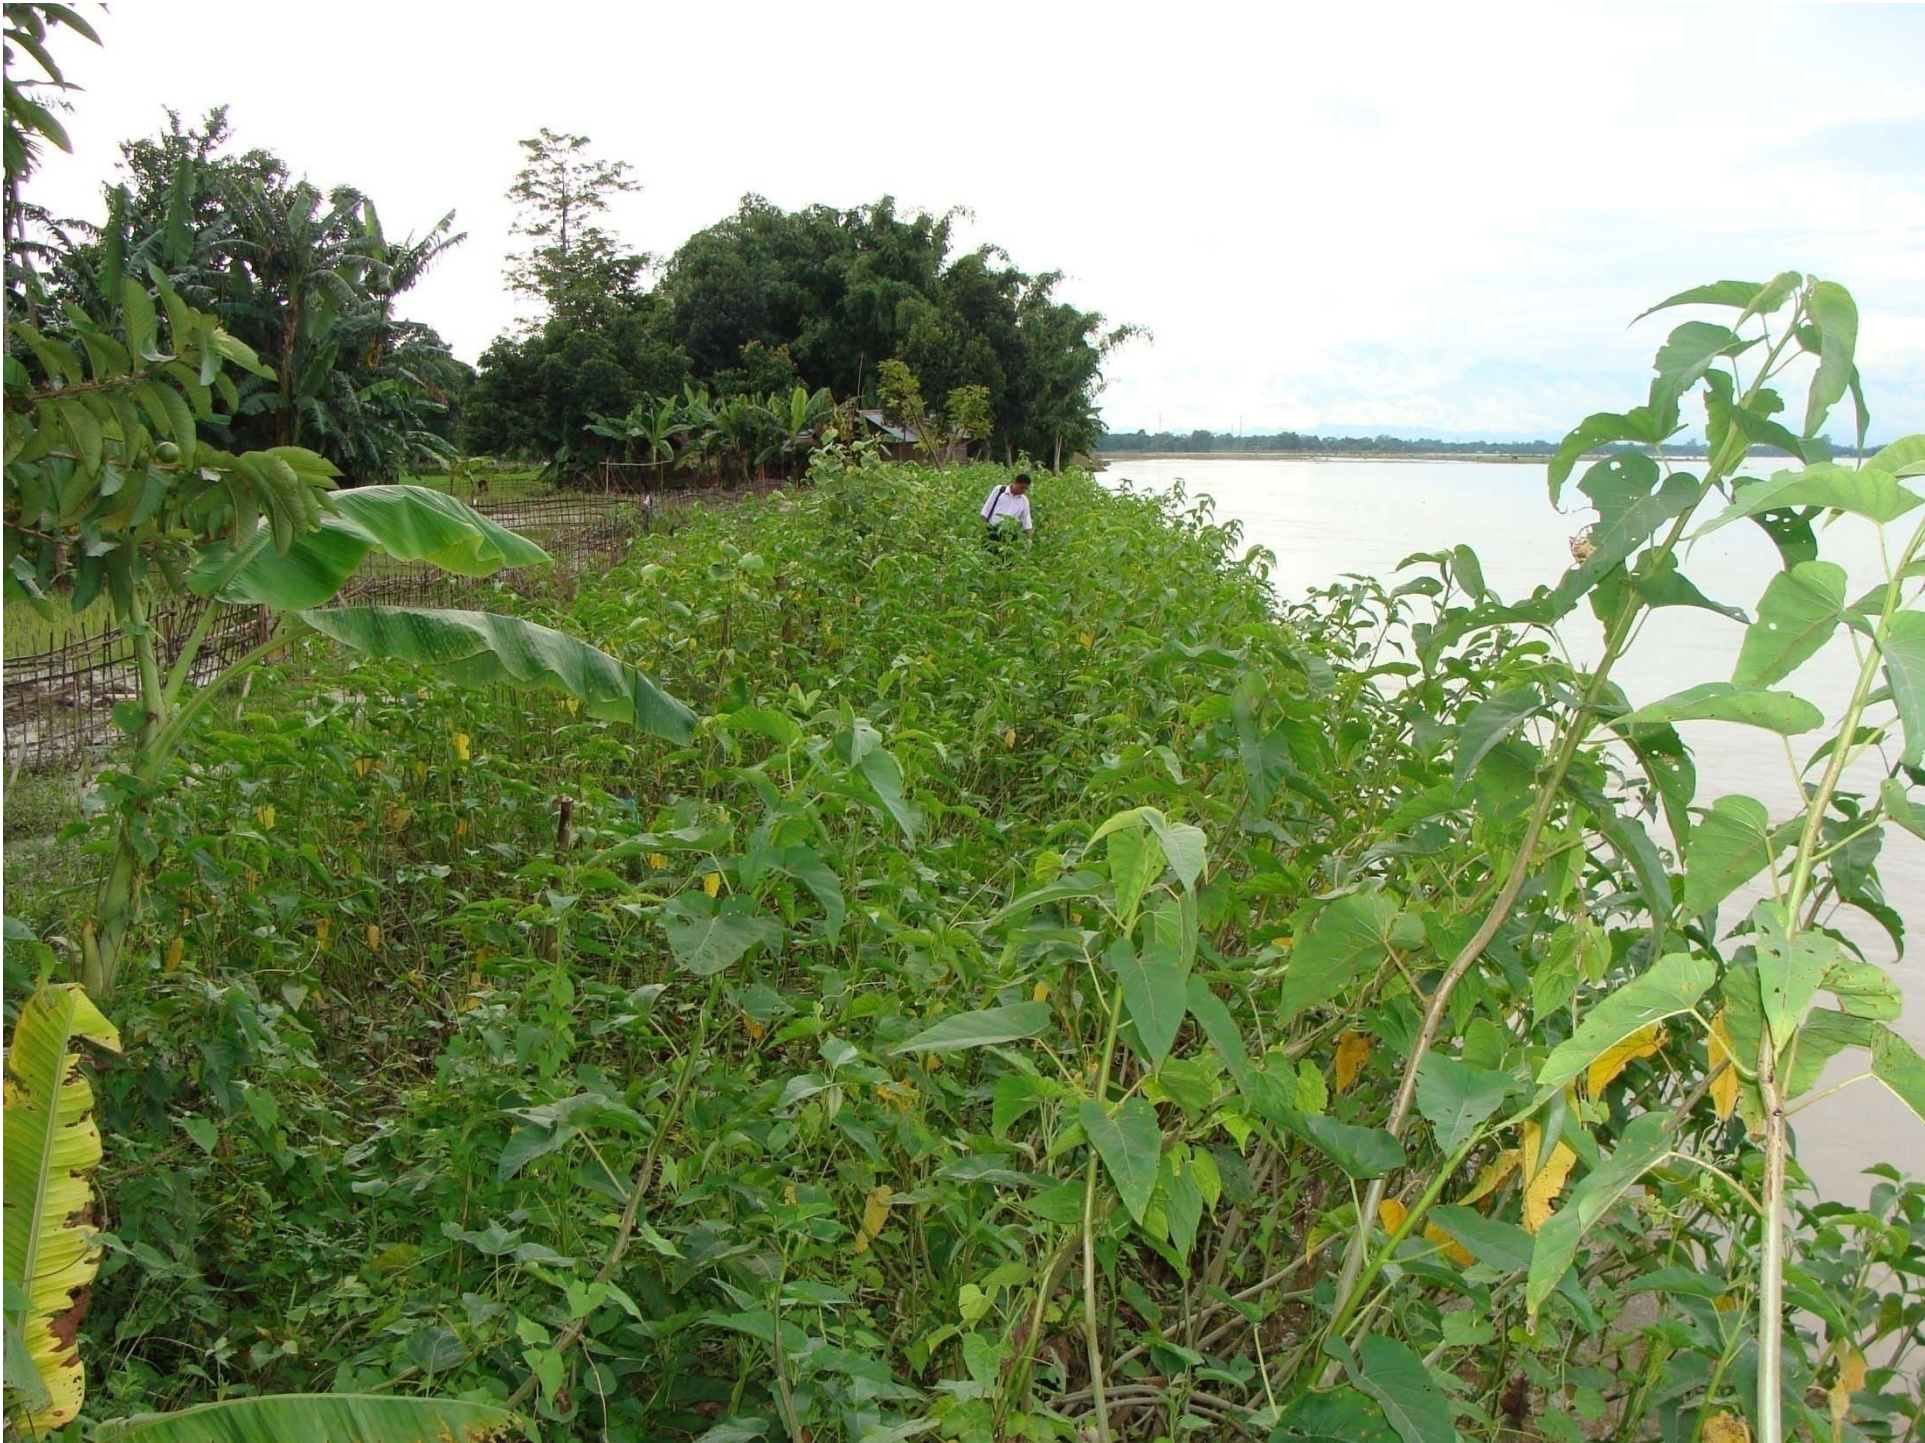
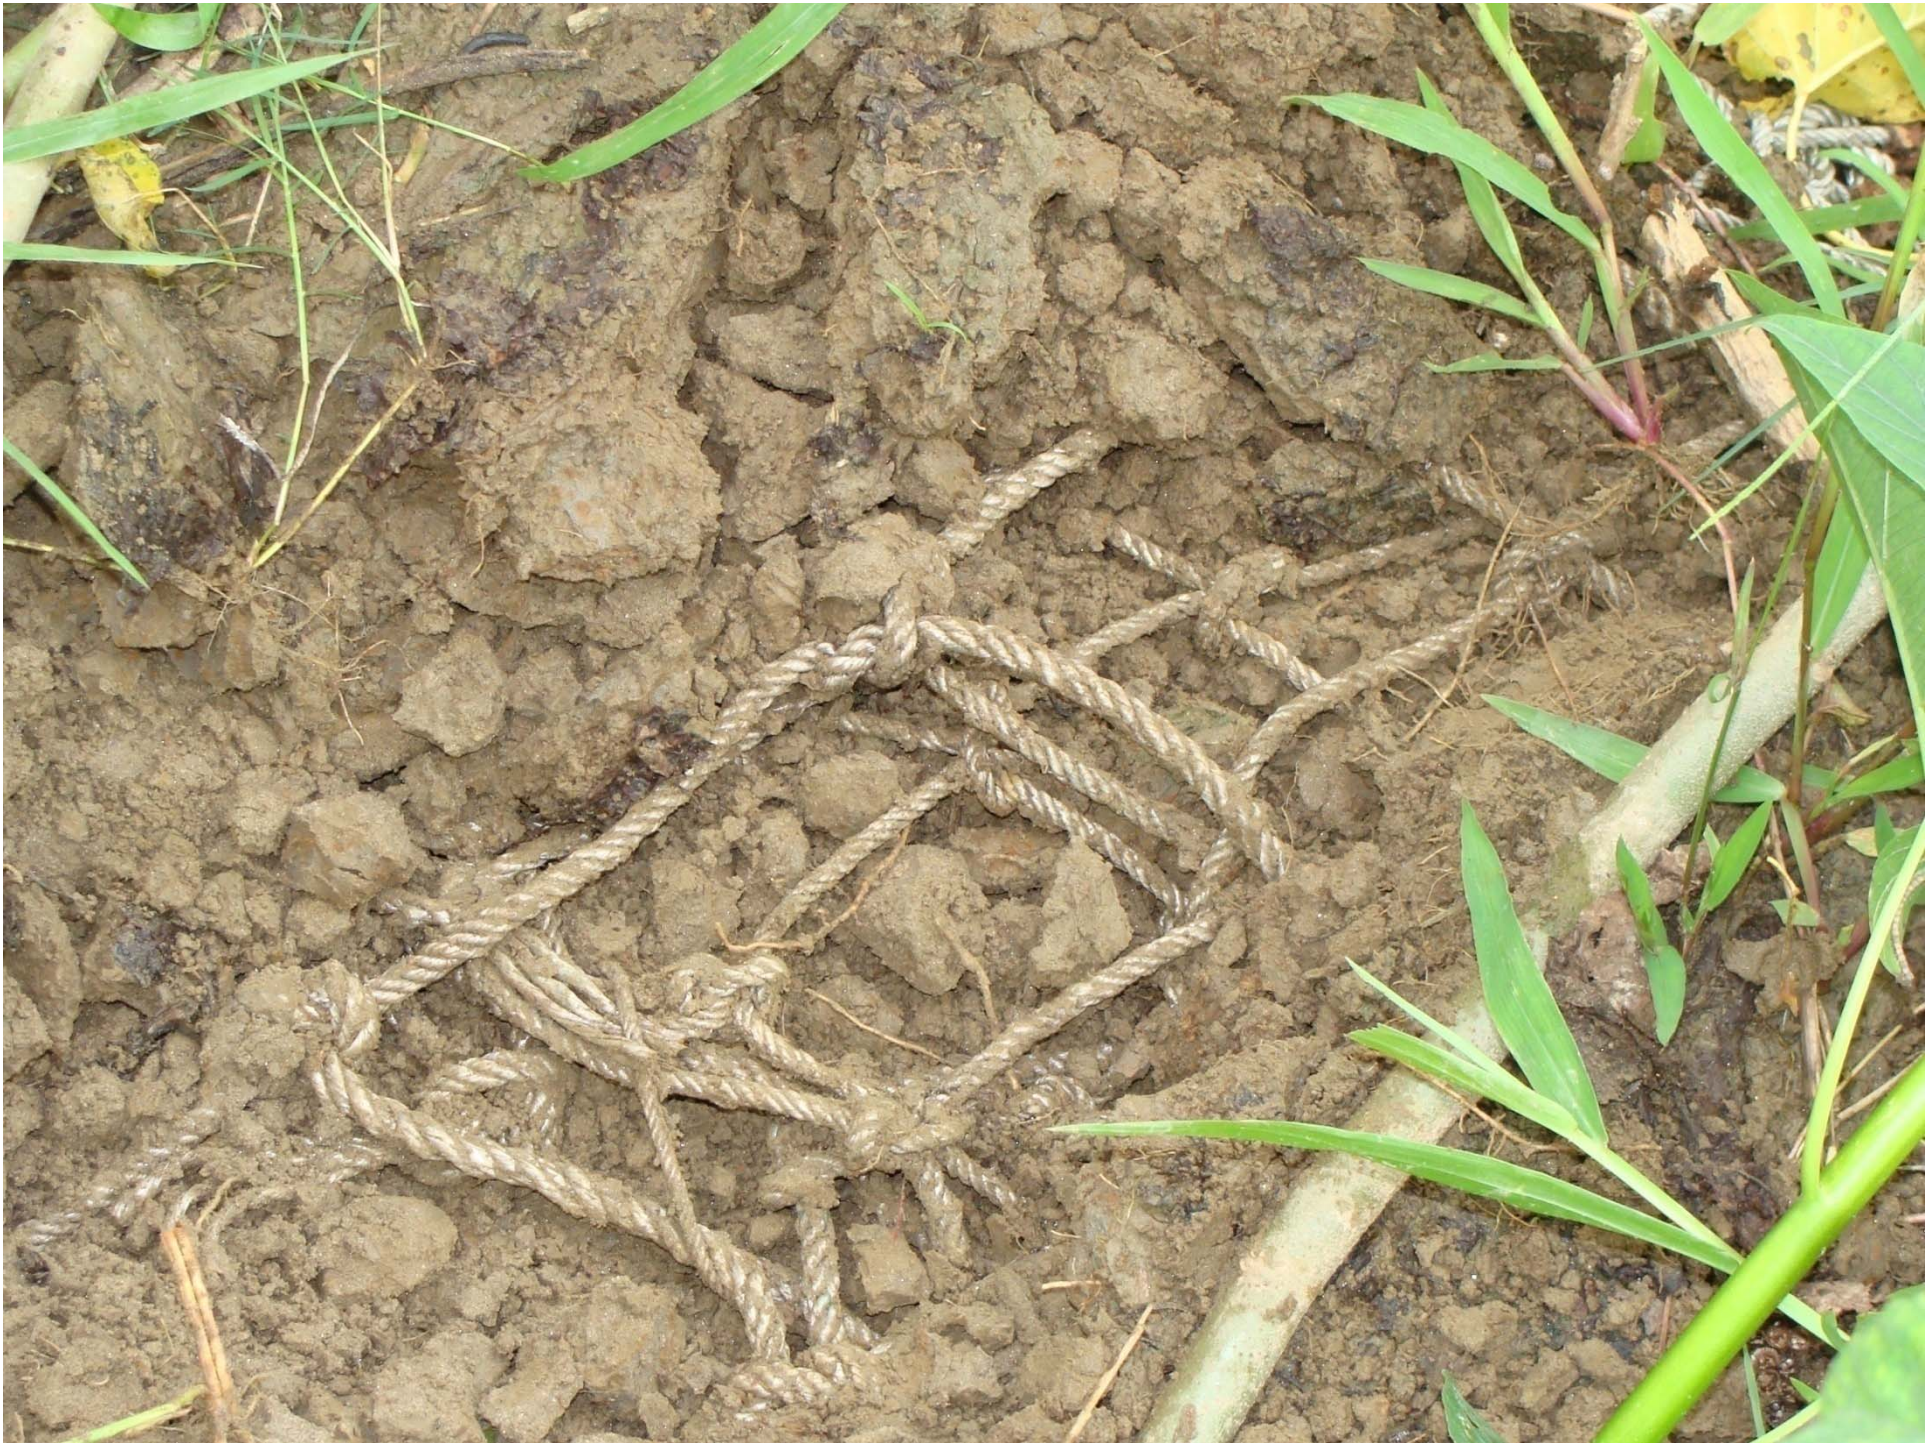
# Net and Bio-system

- Based on the above understanding, bioengineering approach was adopted for controlling bank erosion of Dikrong River in Assam.
- With initiative of Mr. D.Hazarkia of Polygon Foundation, this NEDFi funded project was implemented under the technical guidance and support of IIT Guwahati (Sarma A.K., 2007) and encouraging results were obtained.
- Due to paucity of fund and non-availability biodegradable ecofriendly net, plastic net was applied for initial stability of the planted vegetation.
- To apply this concept in different suitable tributaries, a proper standardization and design guideline is necessary.
- IIT Guwahati is working for preparing standard guideline on vegetative methods of controlling river bank erosion
