Bio-Engineering or Non-Structural  
Techniques developed for mitigation  
of erosion at Majuli Island as a

Pilot Project

Presented By  
**Dr. Arvind Phukan, D.I.C; P.E; D.Sc**  
**(Honorary)**  
**President, Core Professional Group**  
**For the Brahmaputra (CPGB);**  
**Cosulting Engineer;**  
**Former Professor of Civil**  
**Engineering, University**  
**Of Alaska, Anchorage (USA)**

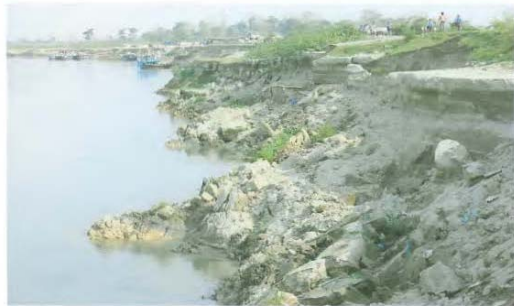
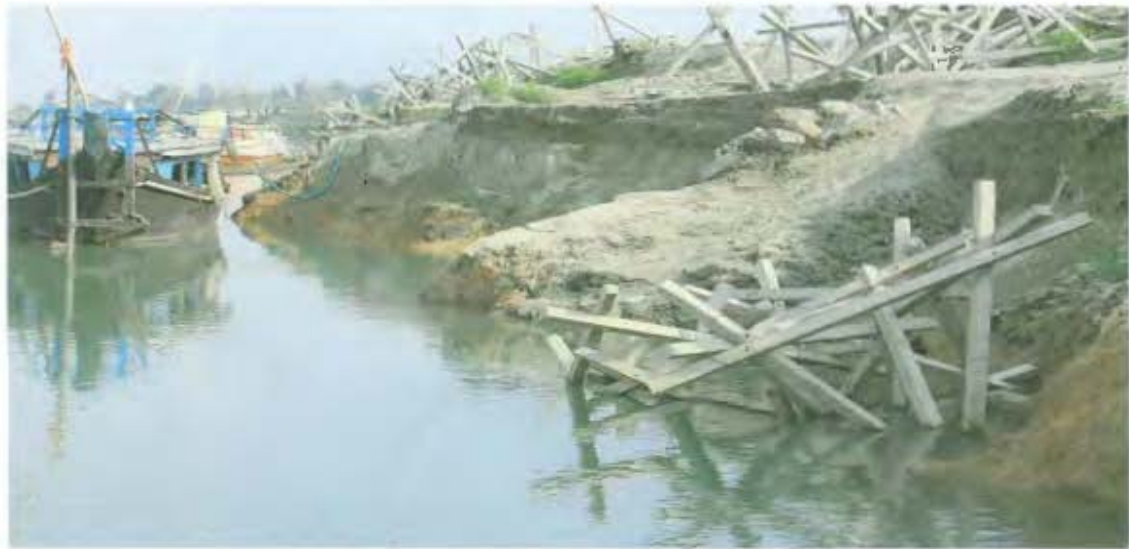
# Progression of Bank Erosion

Observed recently on March 14, 2016.

River bank erosion /Failure at Neematighat

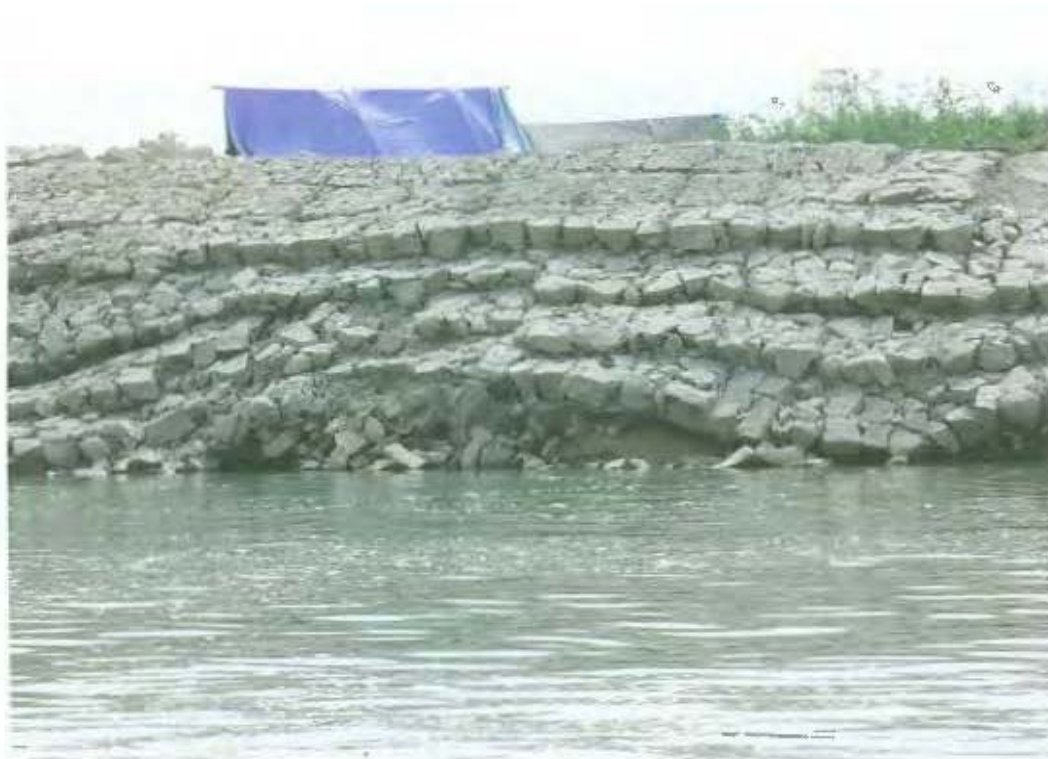
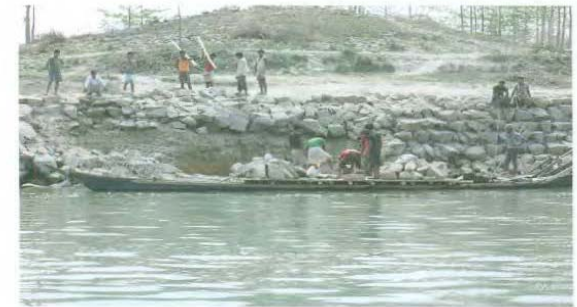
River Bank Revetment Failure at Neematighat

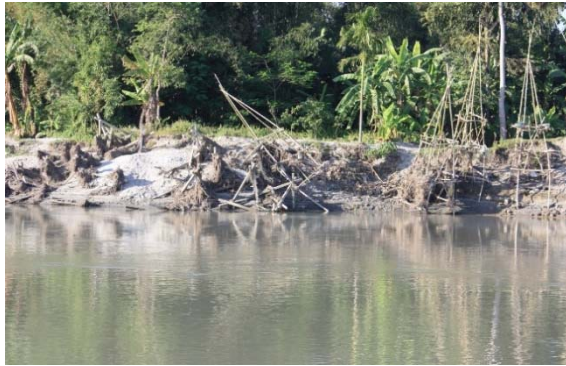
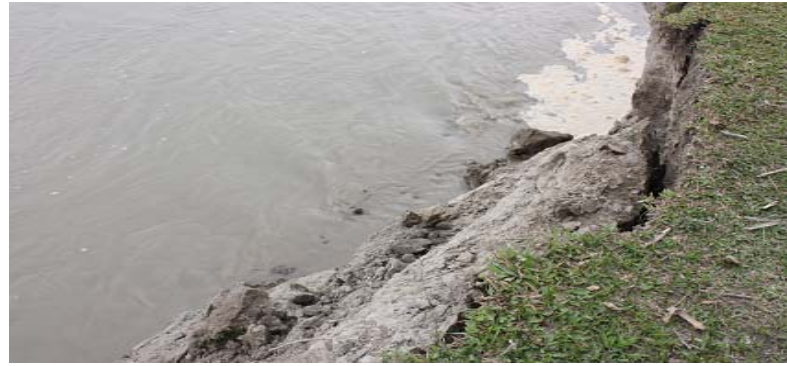
Bank Erosion/Failure at Majuli Island

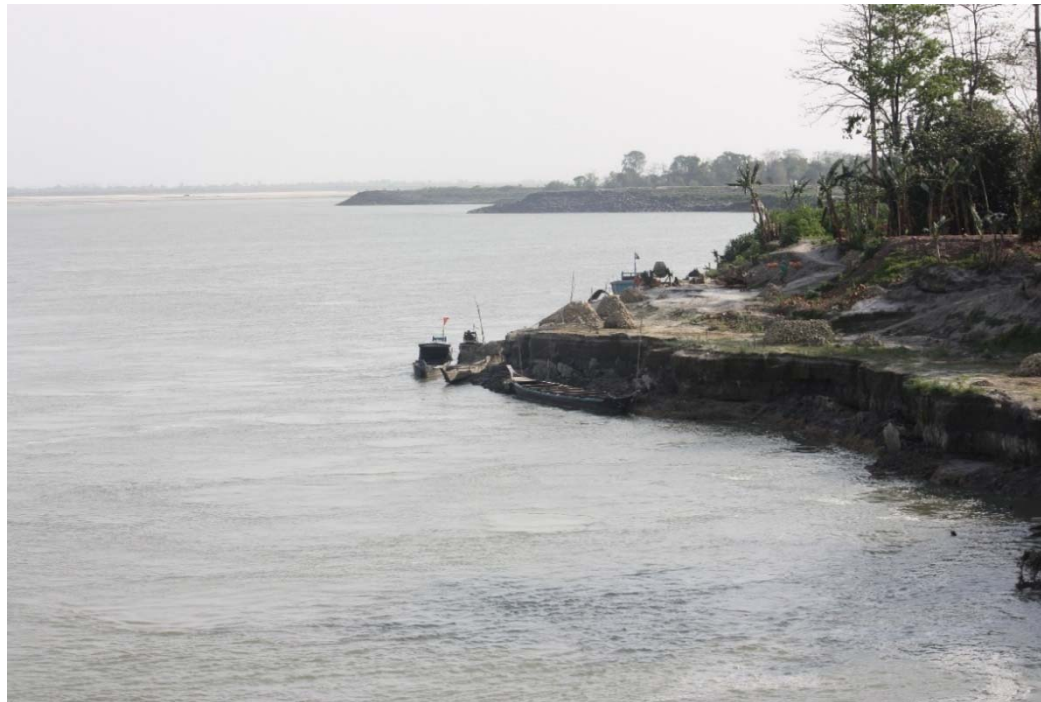
View of the eroded River Bank downstream of Spur No.1

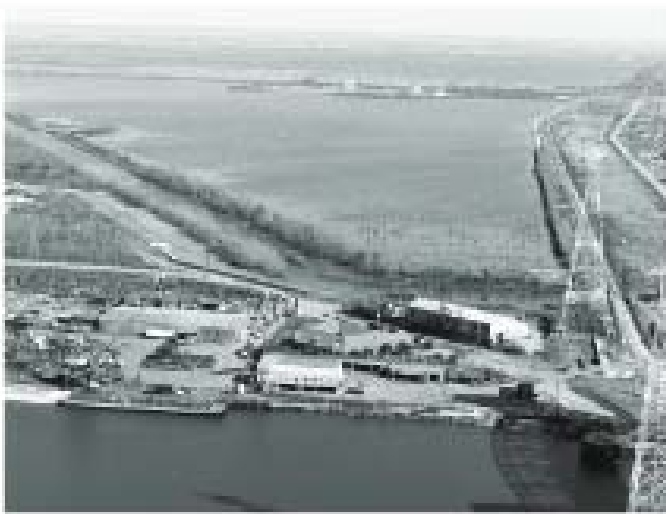
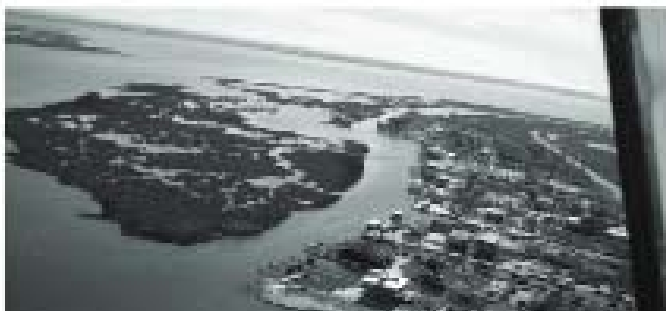
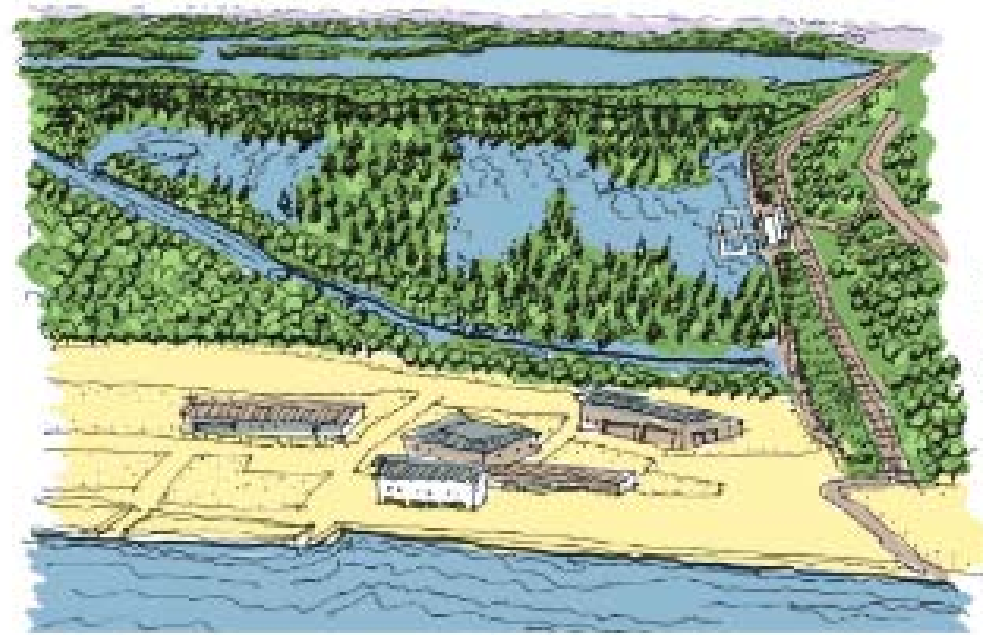
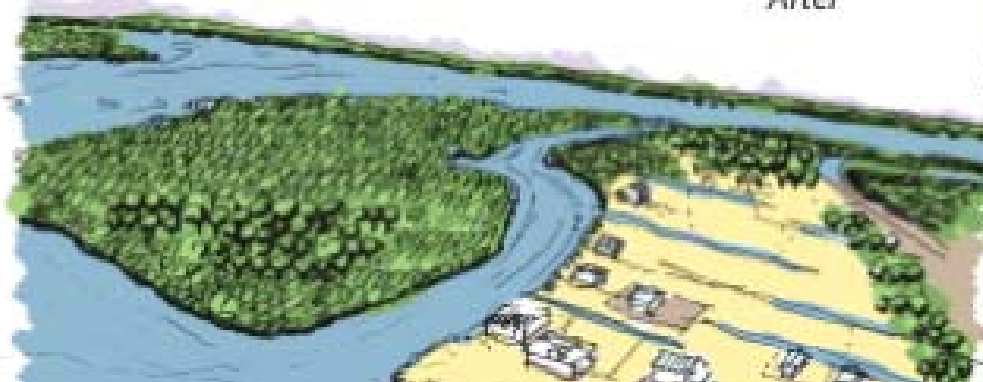
# Examples of Non-structural Measures Designed by the CPGB Team Members: Floodplain Ecosystem restoration in the Lake Borgne area of Mississippi River outlet

*Before*

*After*

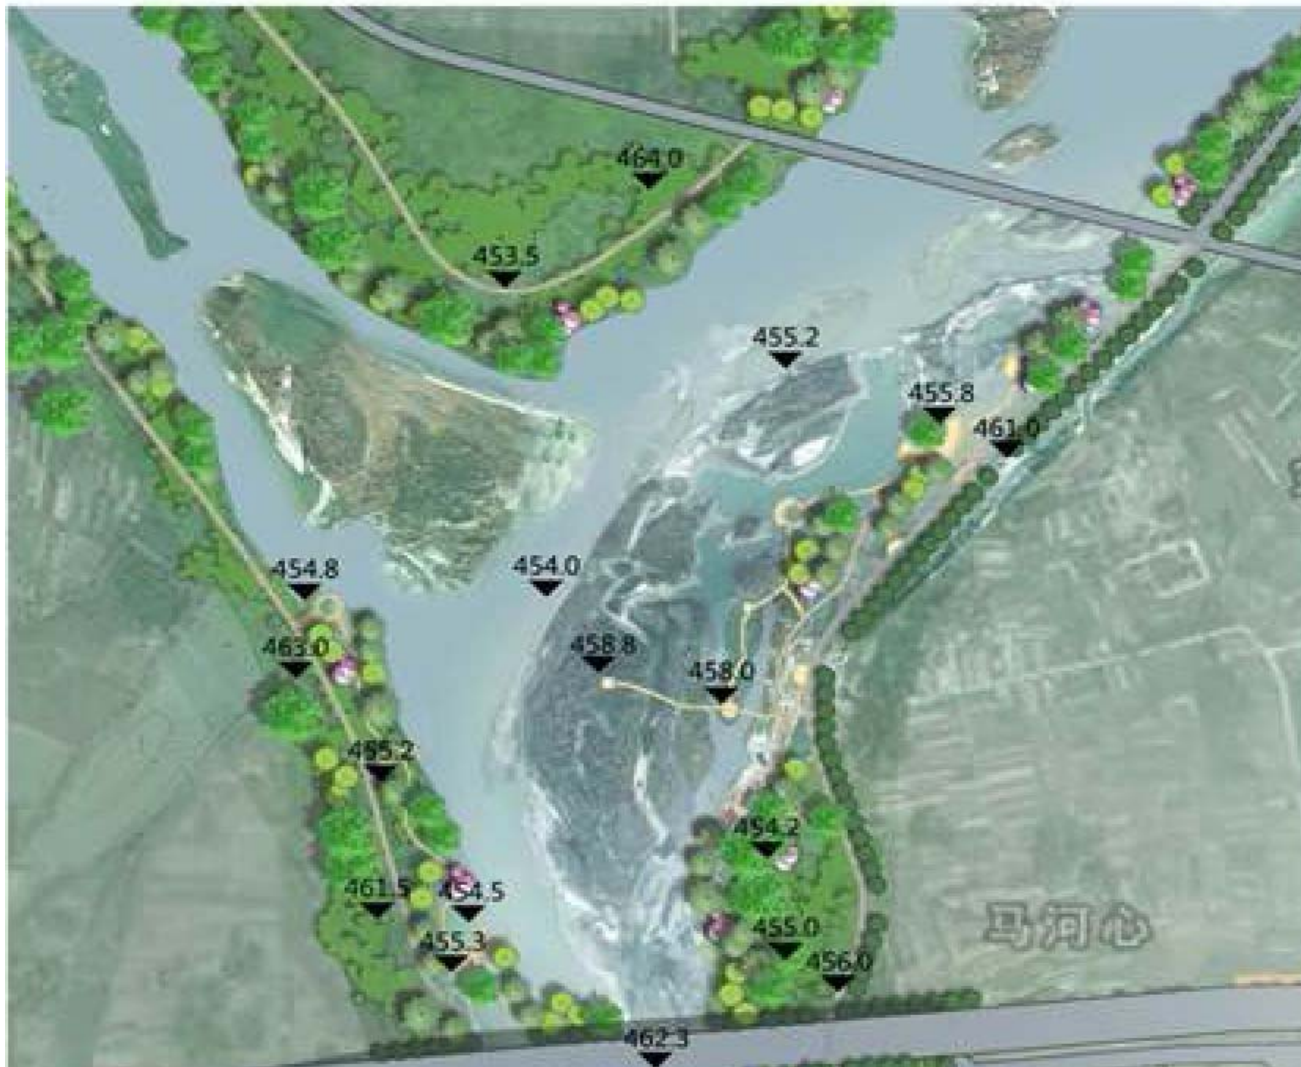
# Examples (Contd.): Example of a robust river bank erosion mitigation plan (in China)
