**Govt. of Assam**  
**WATER RESOURCES DEPARTMENT**

# **Good Practices in Dealing with River Bank Erosion Problems in Assam**

**Presented by :-**  
**Dr. R. K. Goswami, Water Resources Department, Assam**

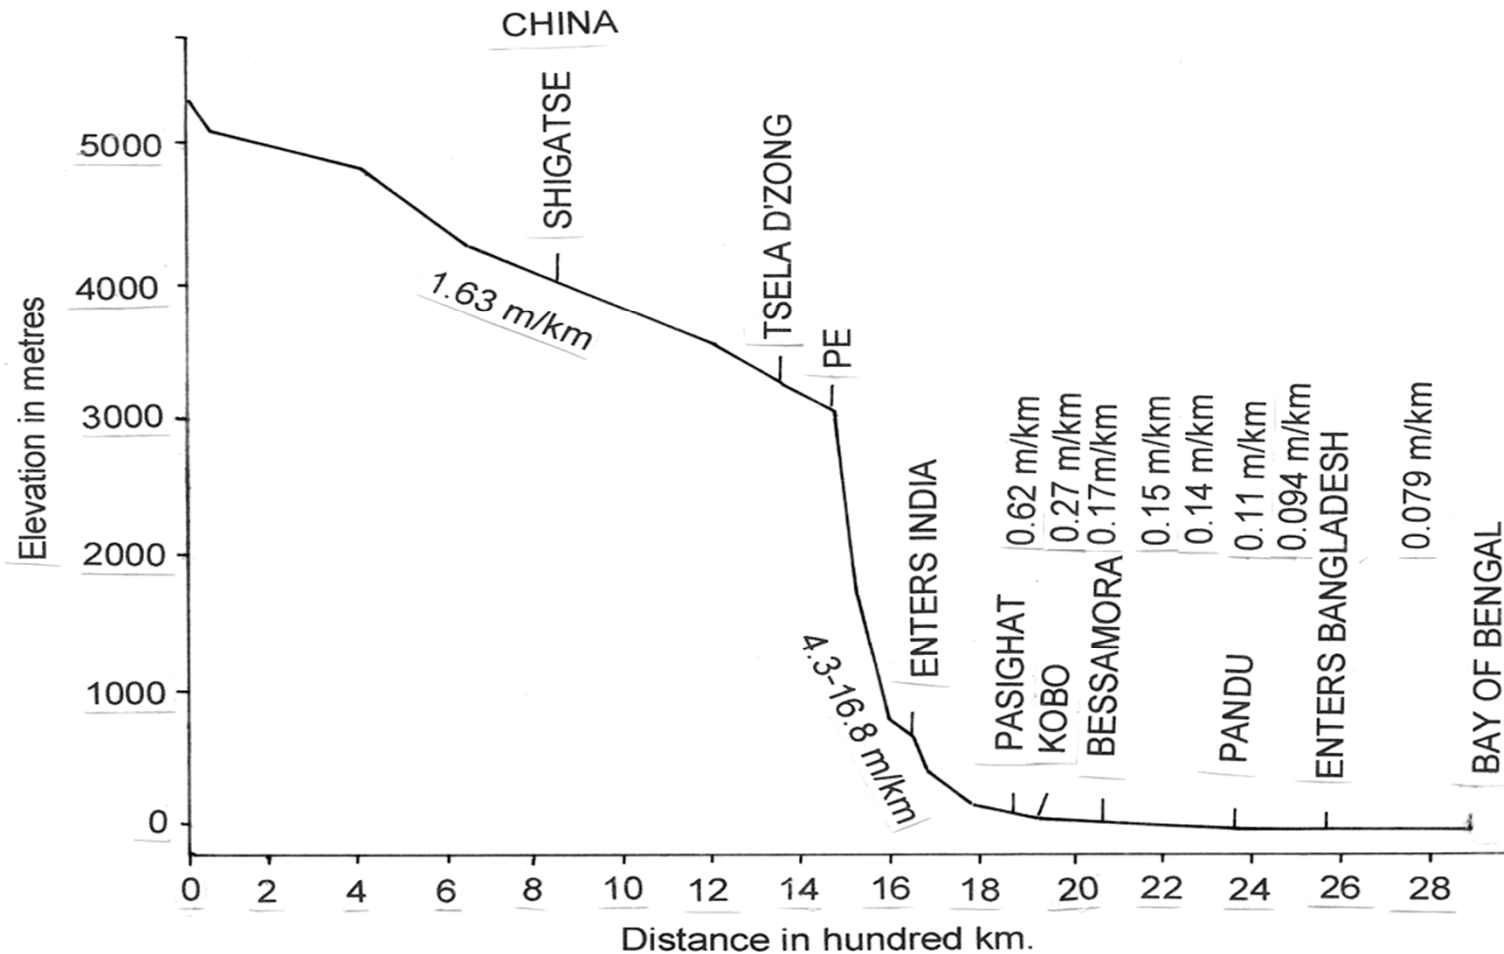
# LONGITUDINAL PROFILE OF THE BRAHMAPUTRA RIVER SHOWING ITS GRADIENT AT DIFFERENT PLACES

The sudden drop in elevation of the river (around 3 km in a distance of 300 km) indicates the energy gained before entering Assam.

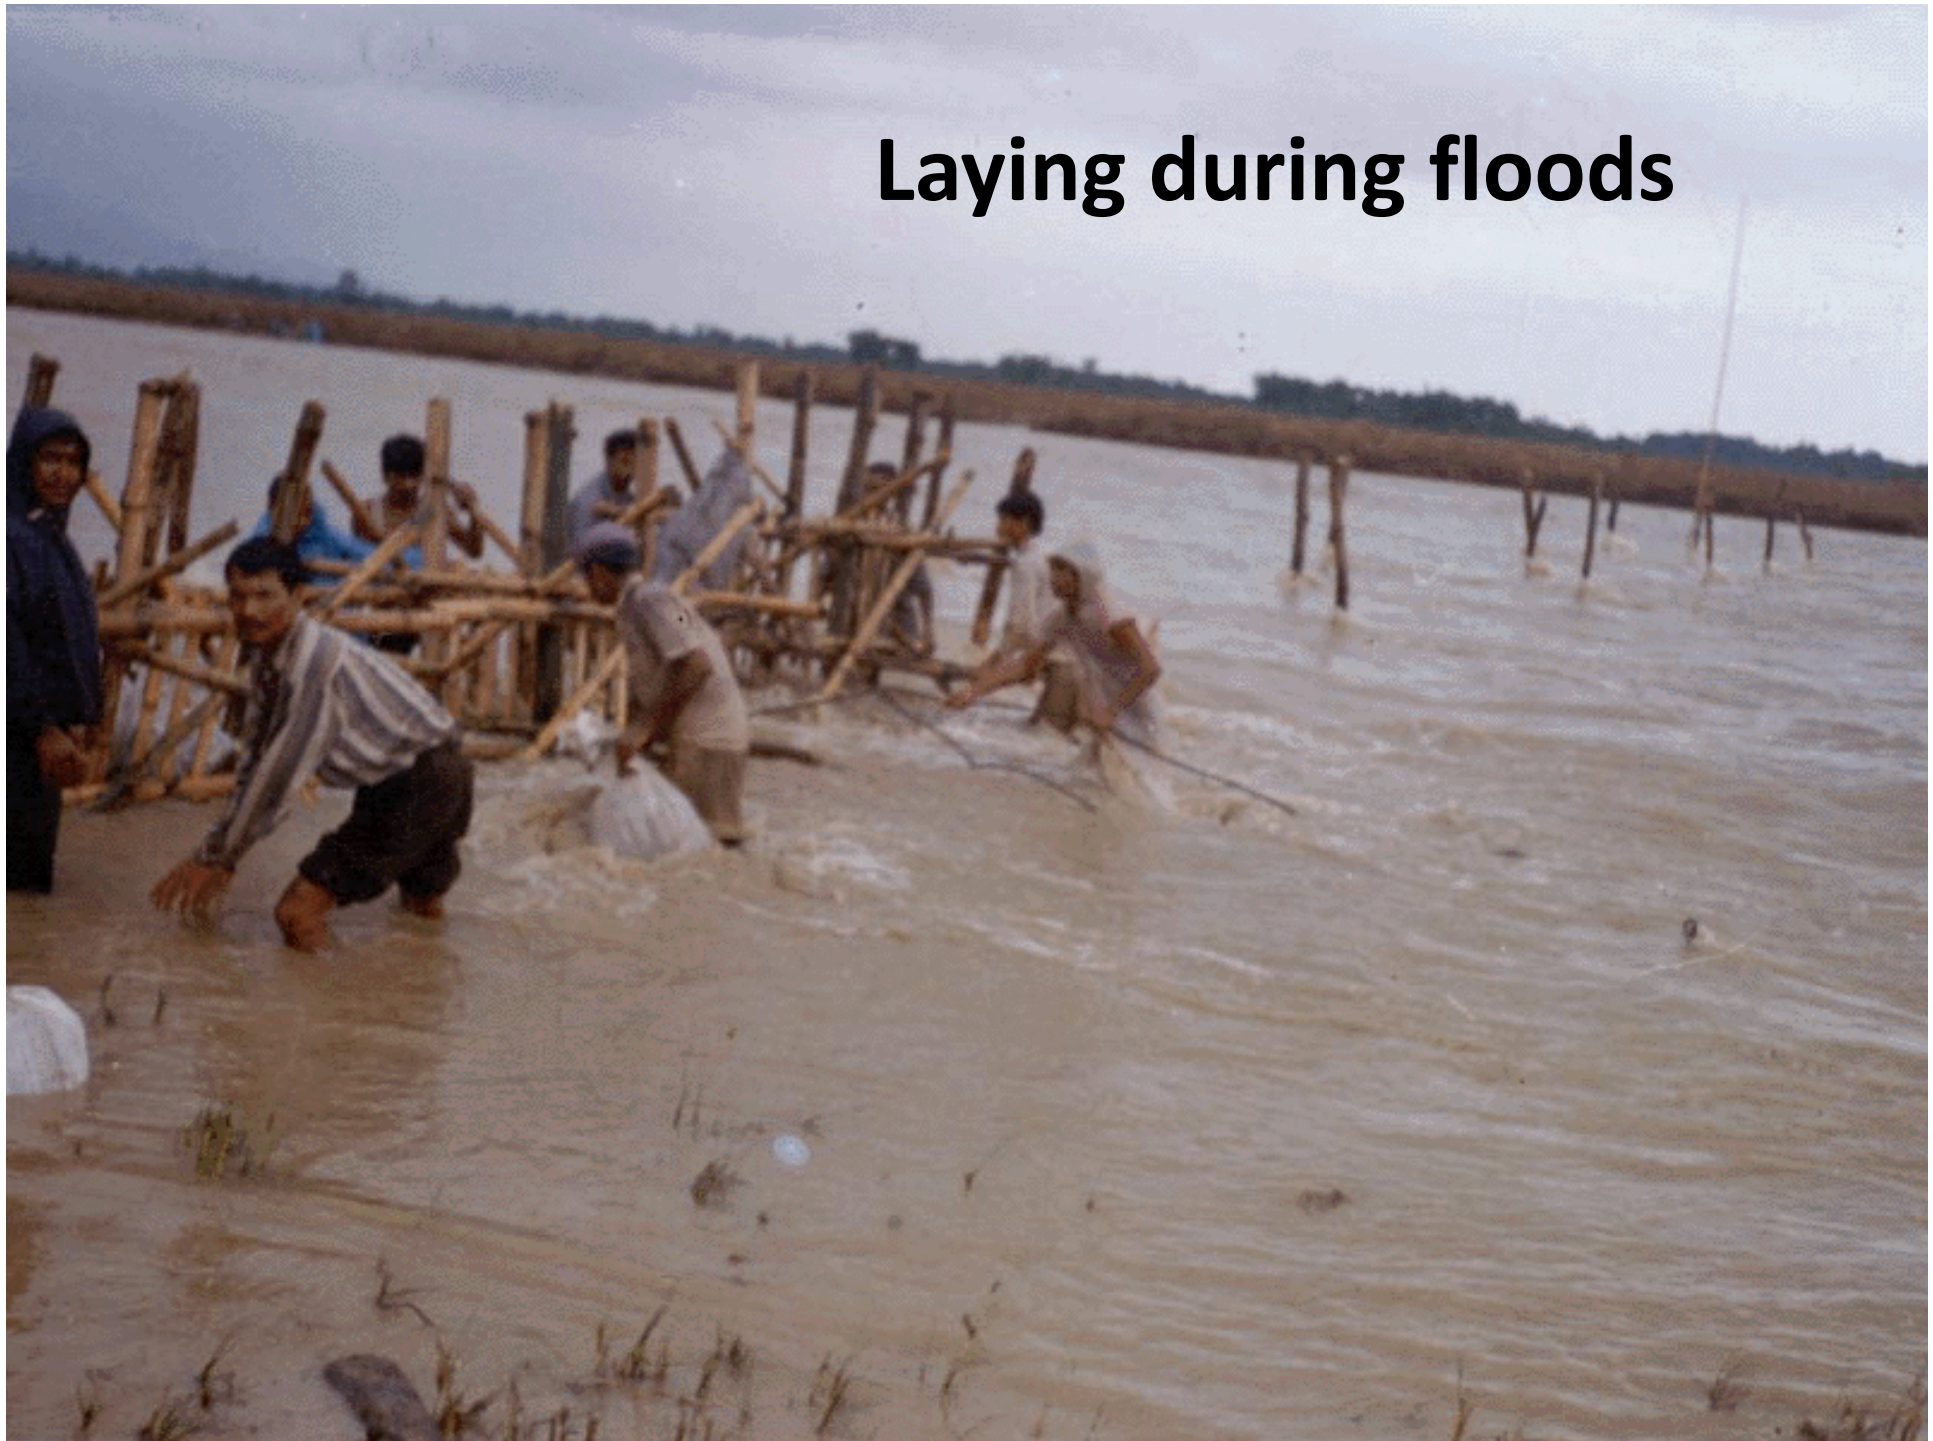
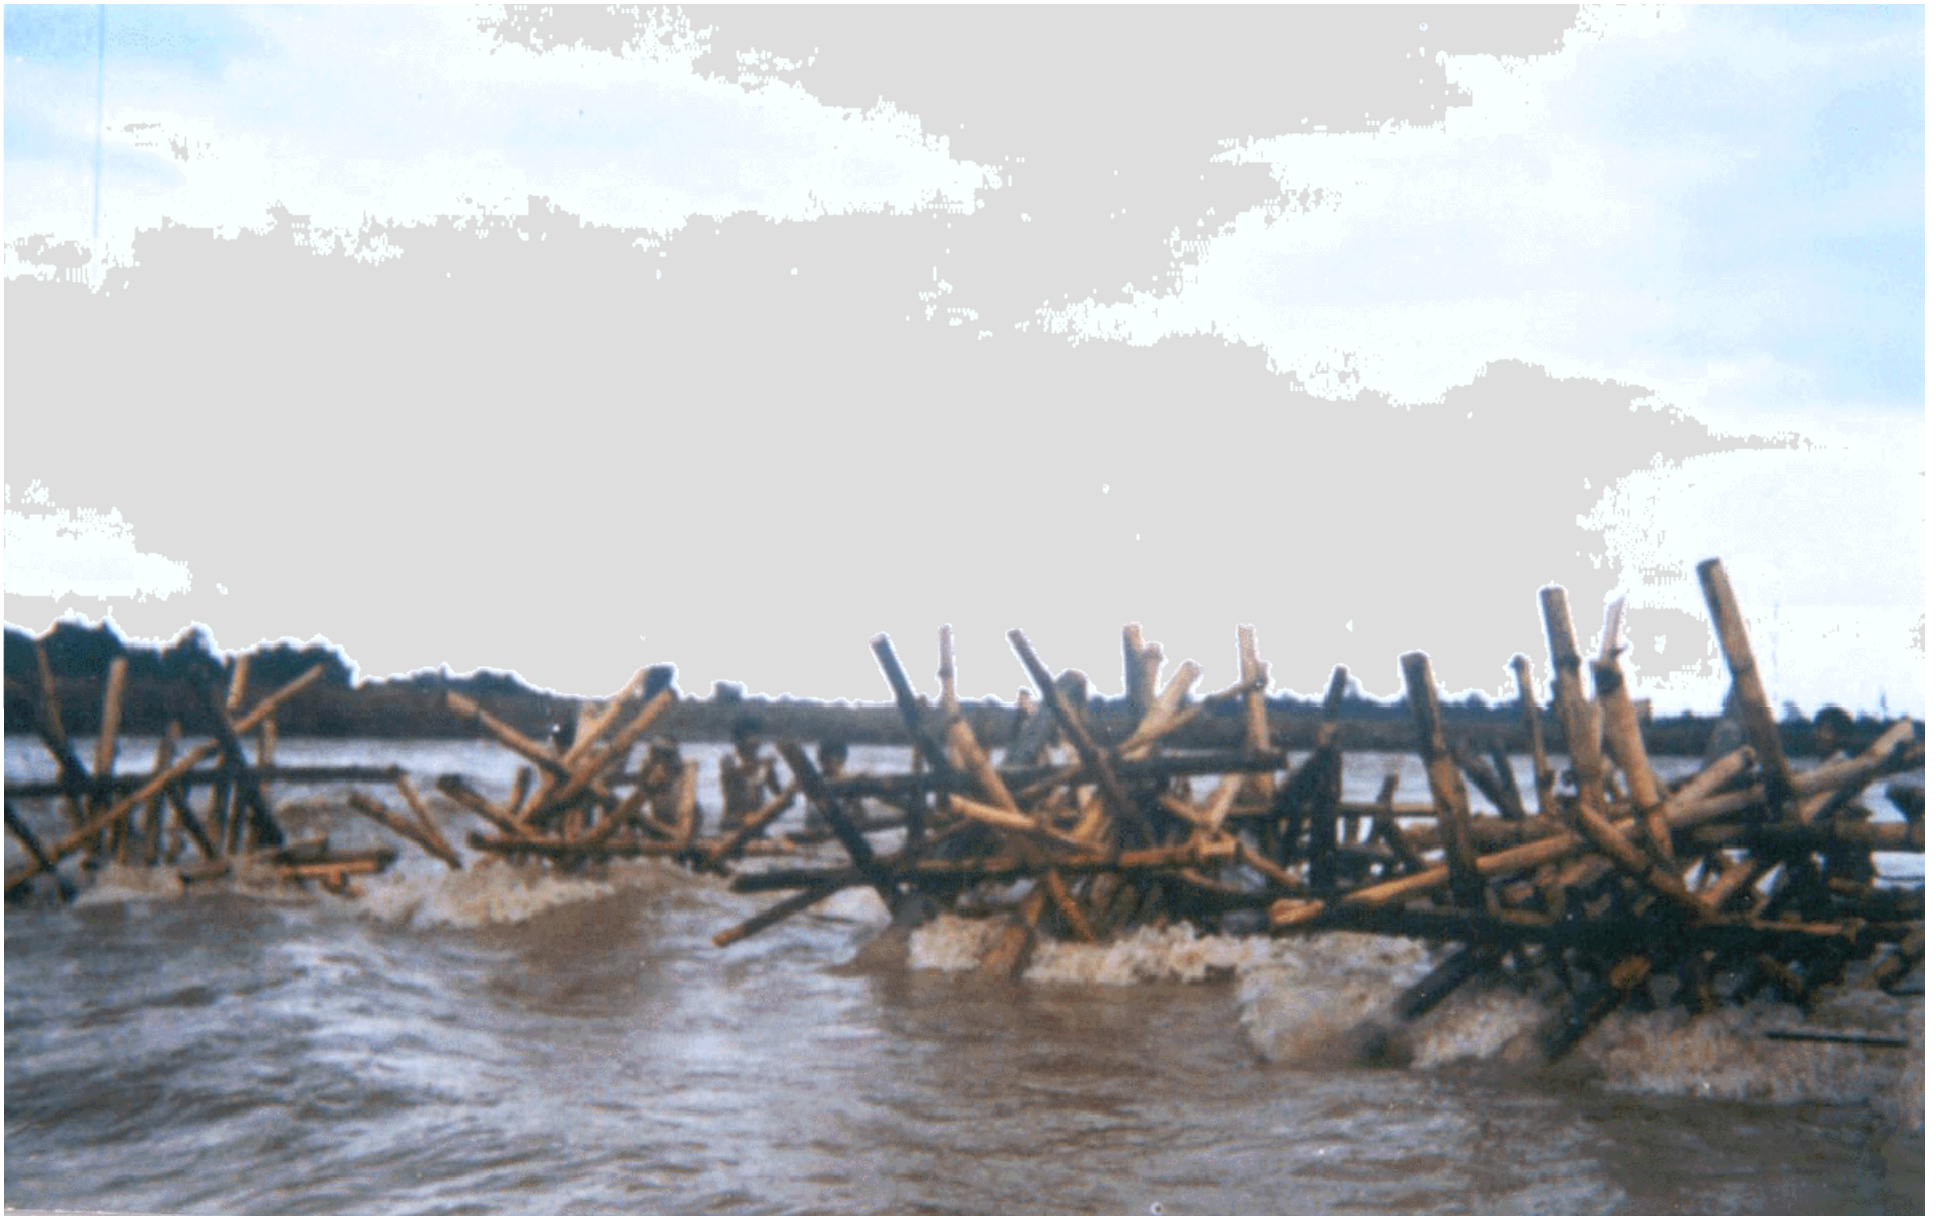
# Laying during floods

**Porcupines in Action (during floods)**

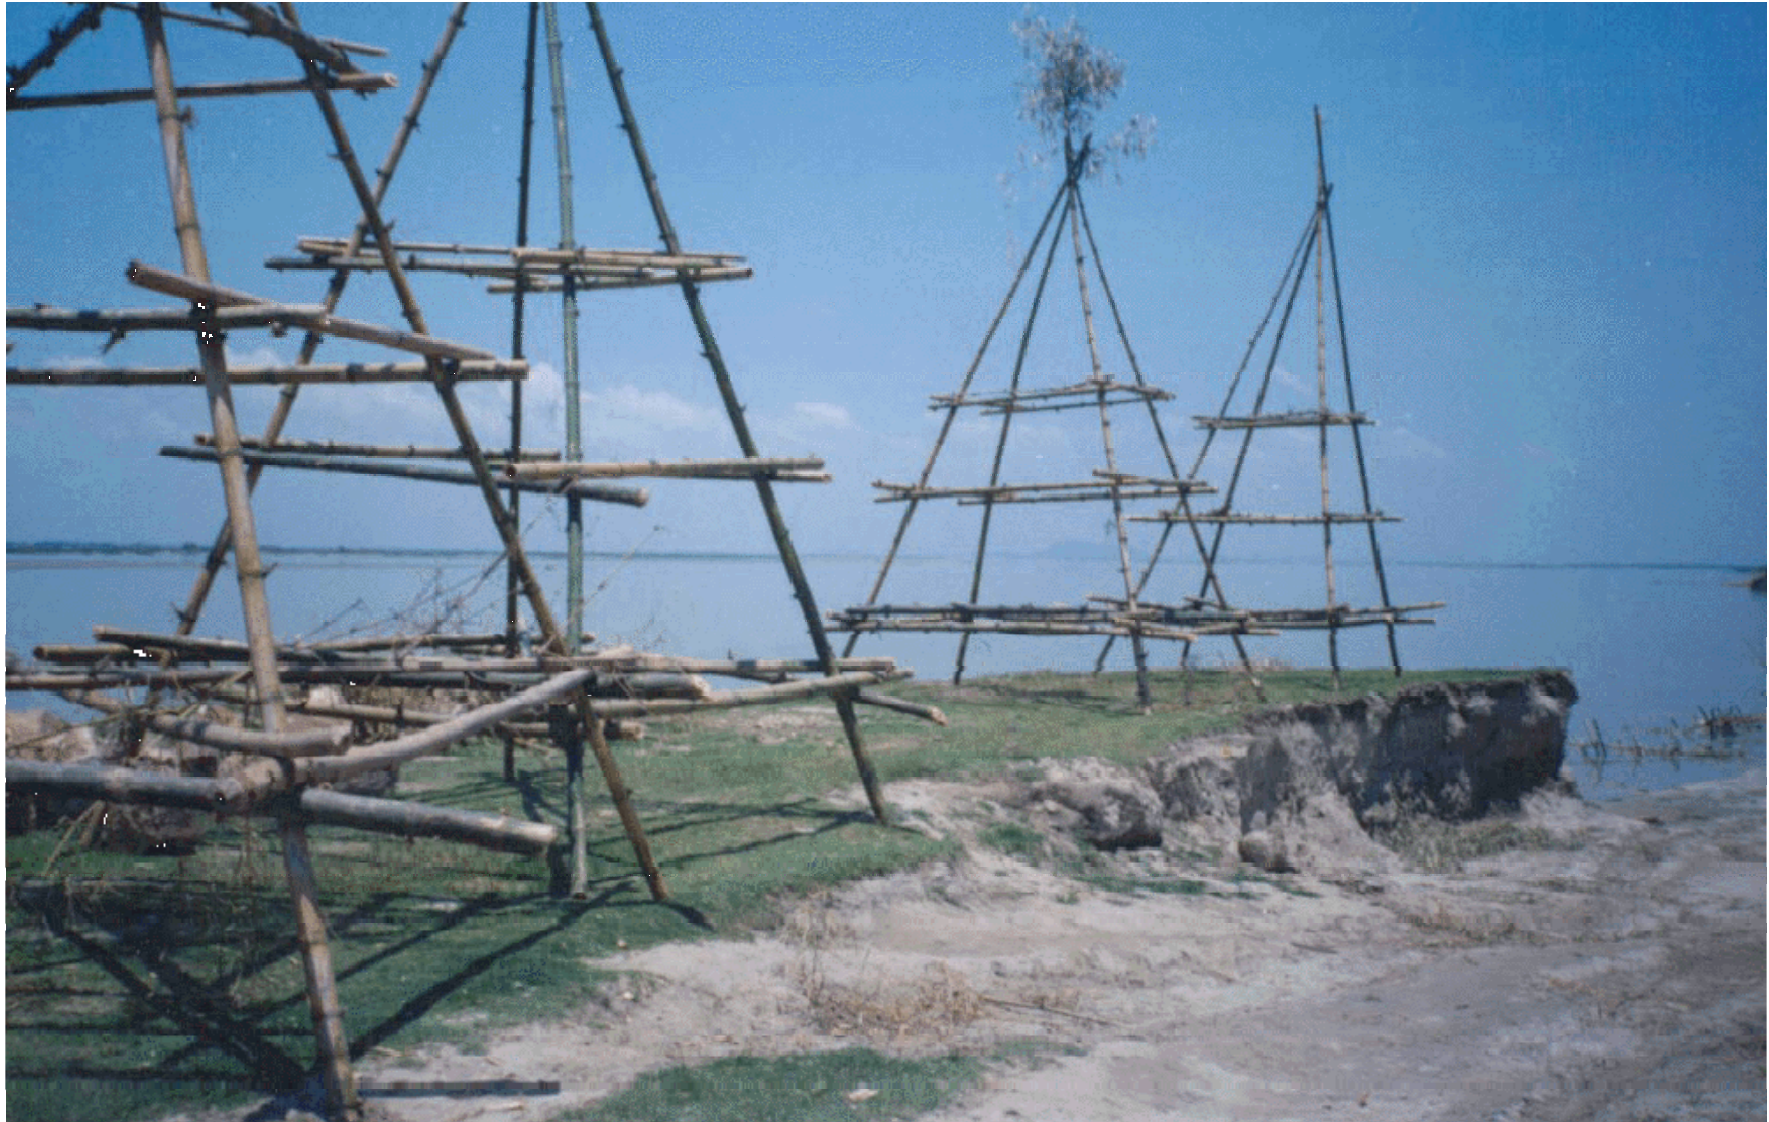
## Elements : Cribs (Normal)

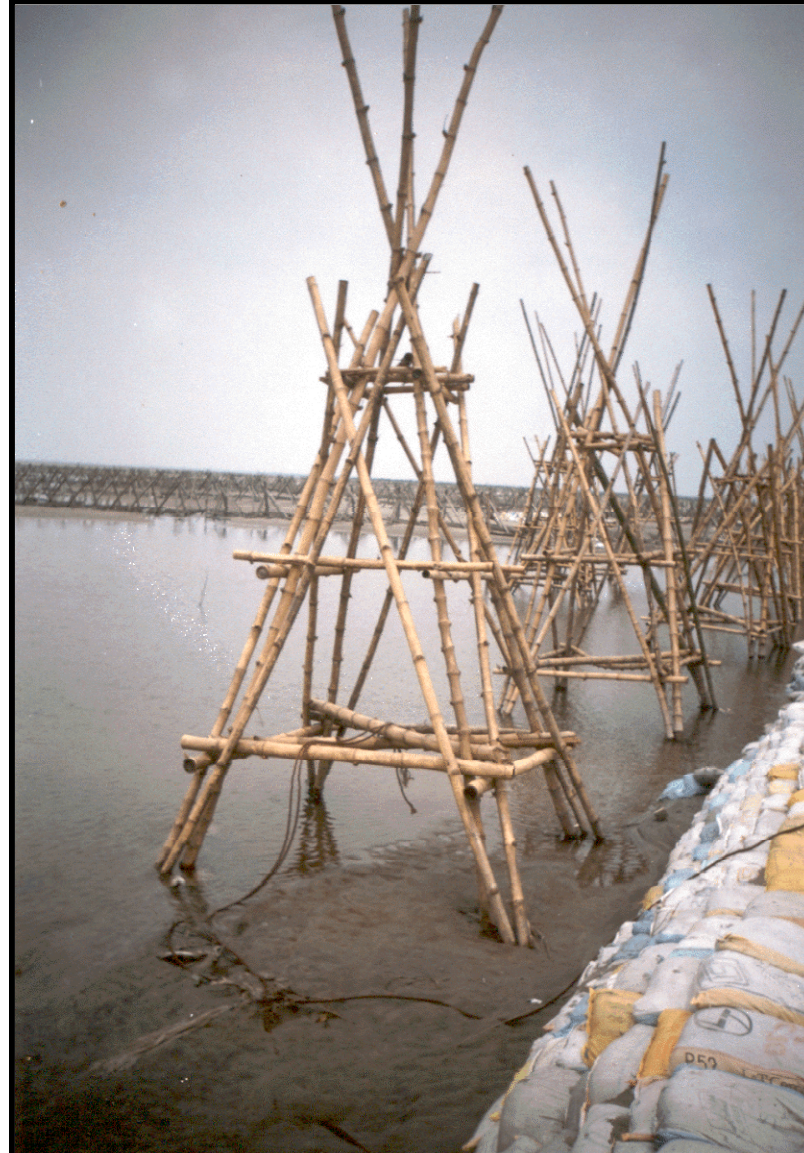
Elements : Cribs (strong)

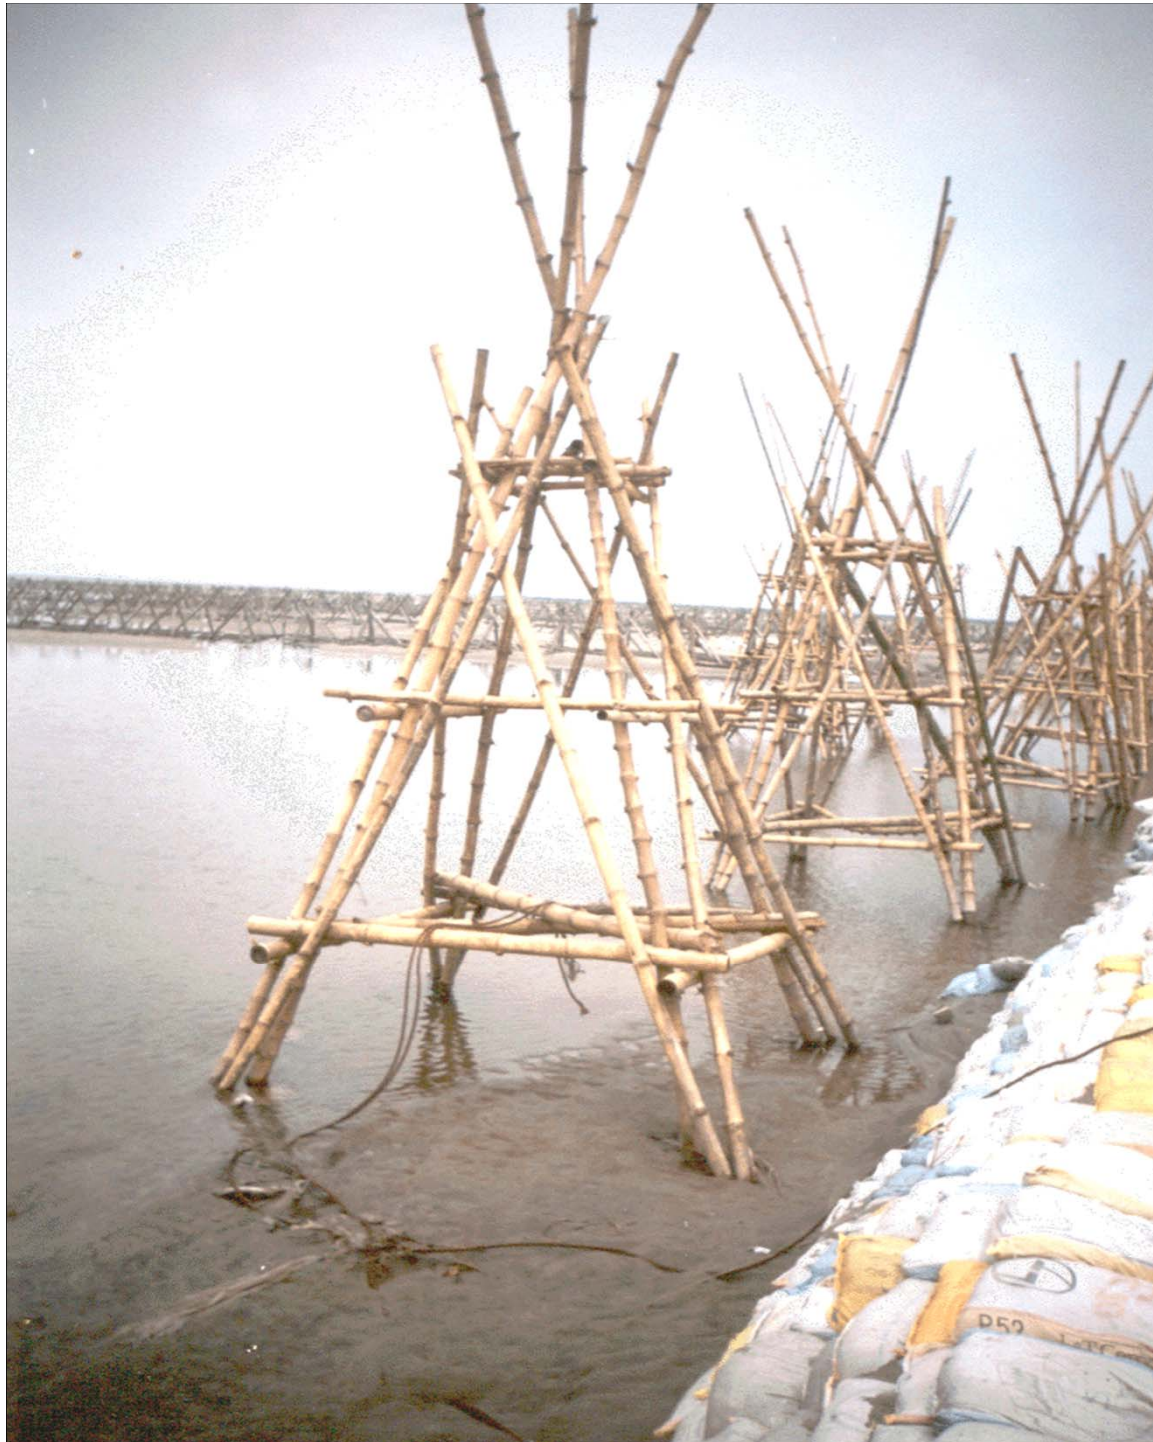
**Cribs with  
double  
members and  
cross bracings  
for strength.**

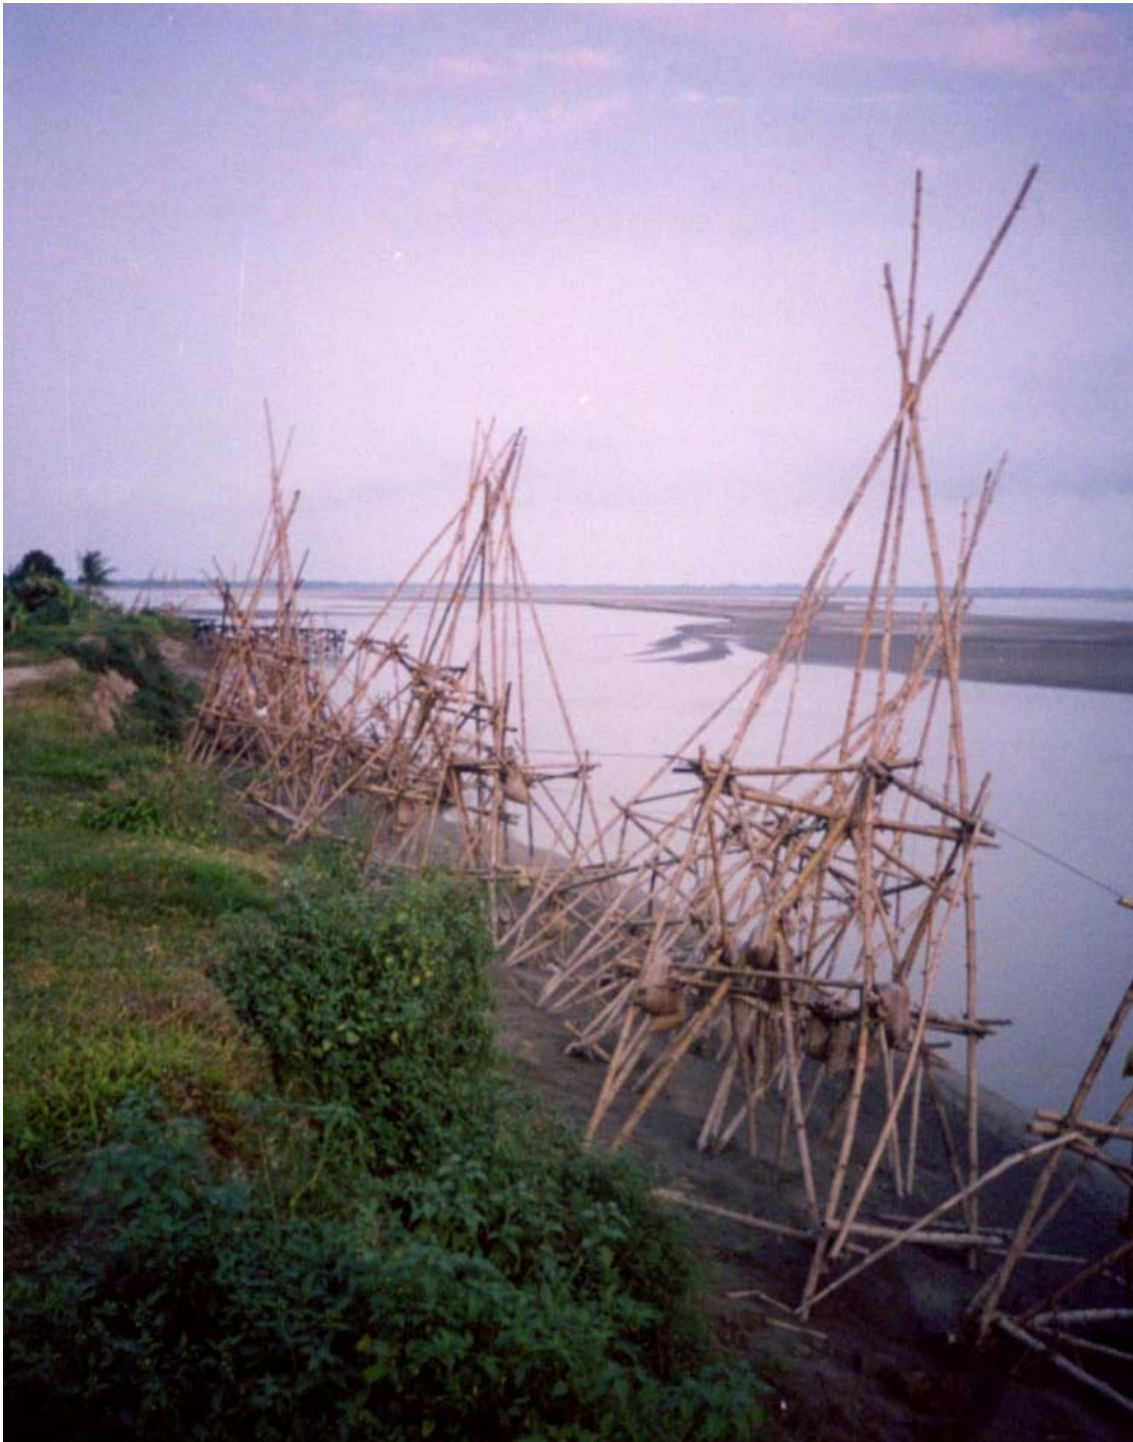
**Cribs aligned in  
single row**

**May not be very  
effective**

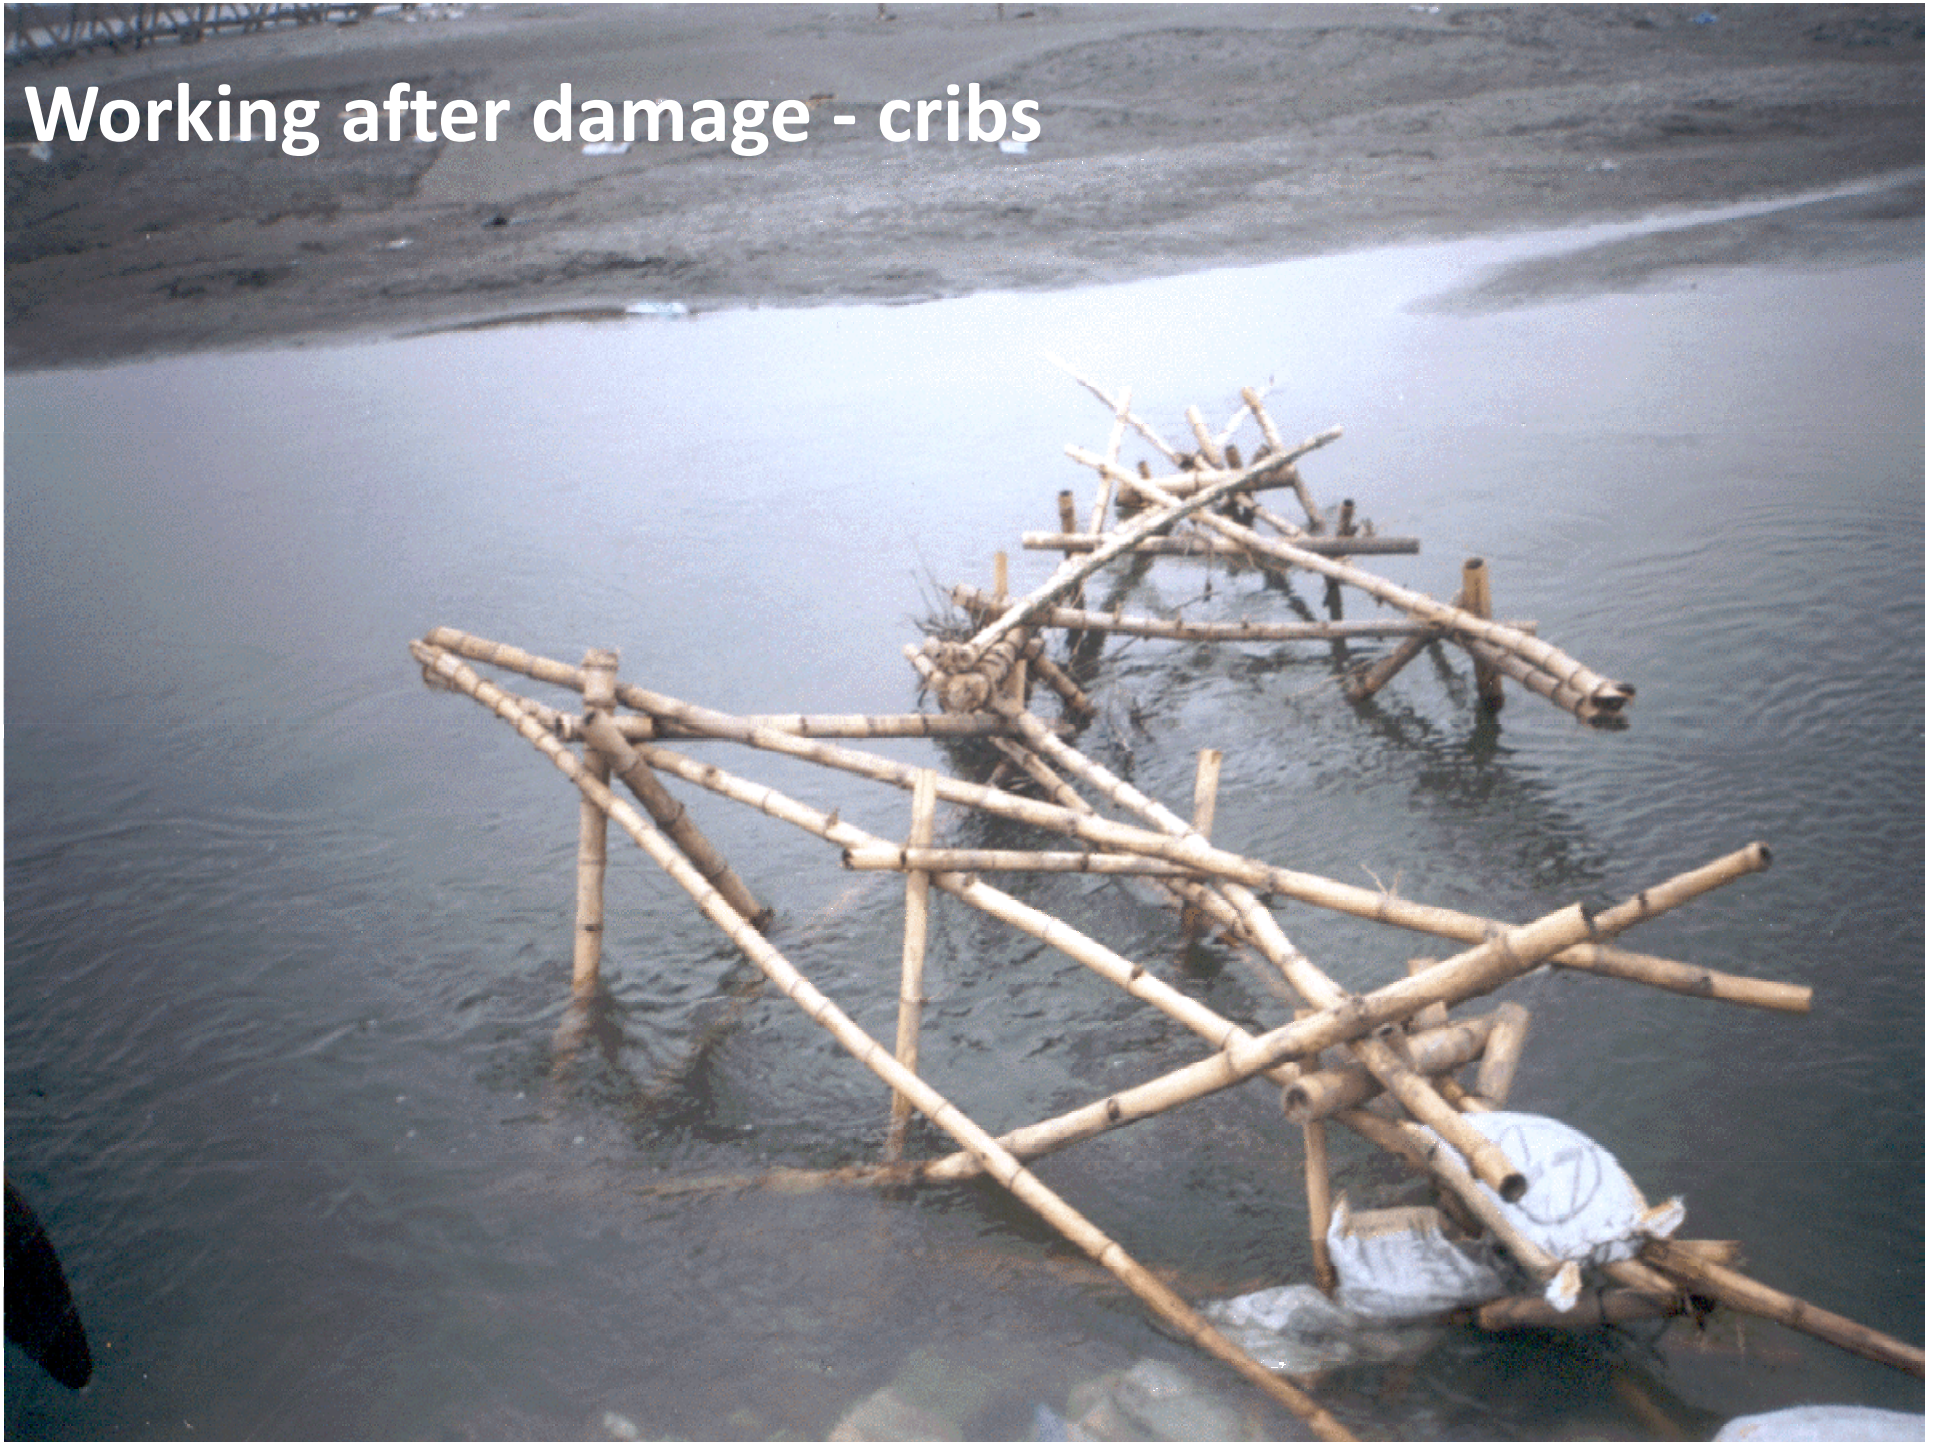
Working after damage - cribs

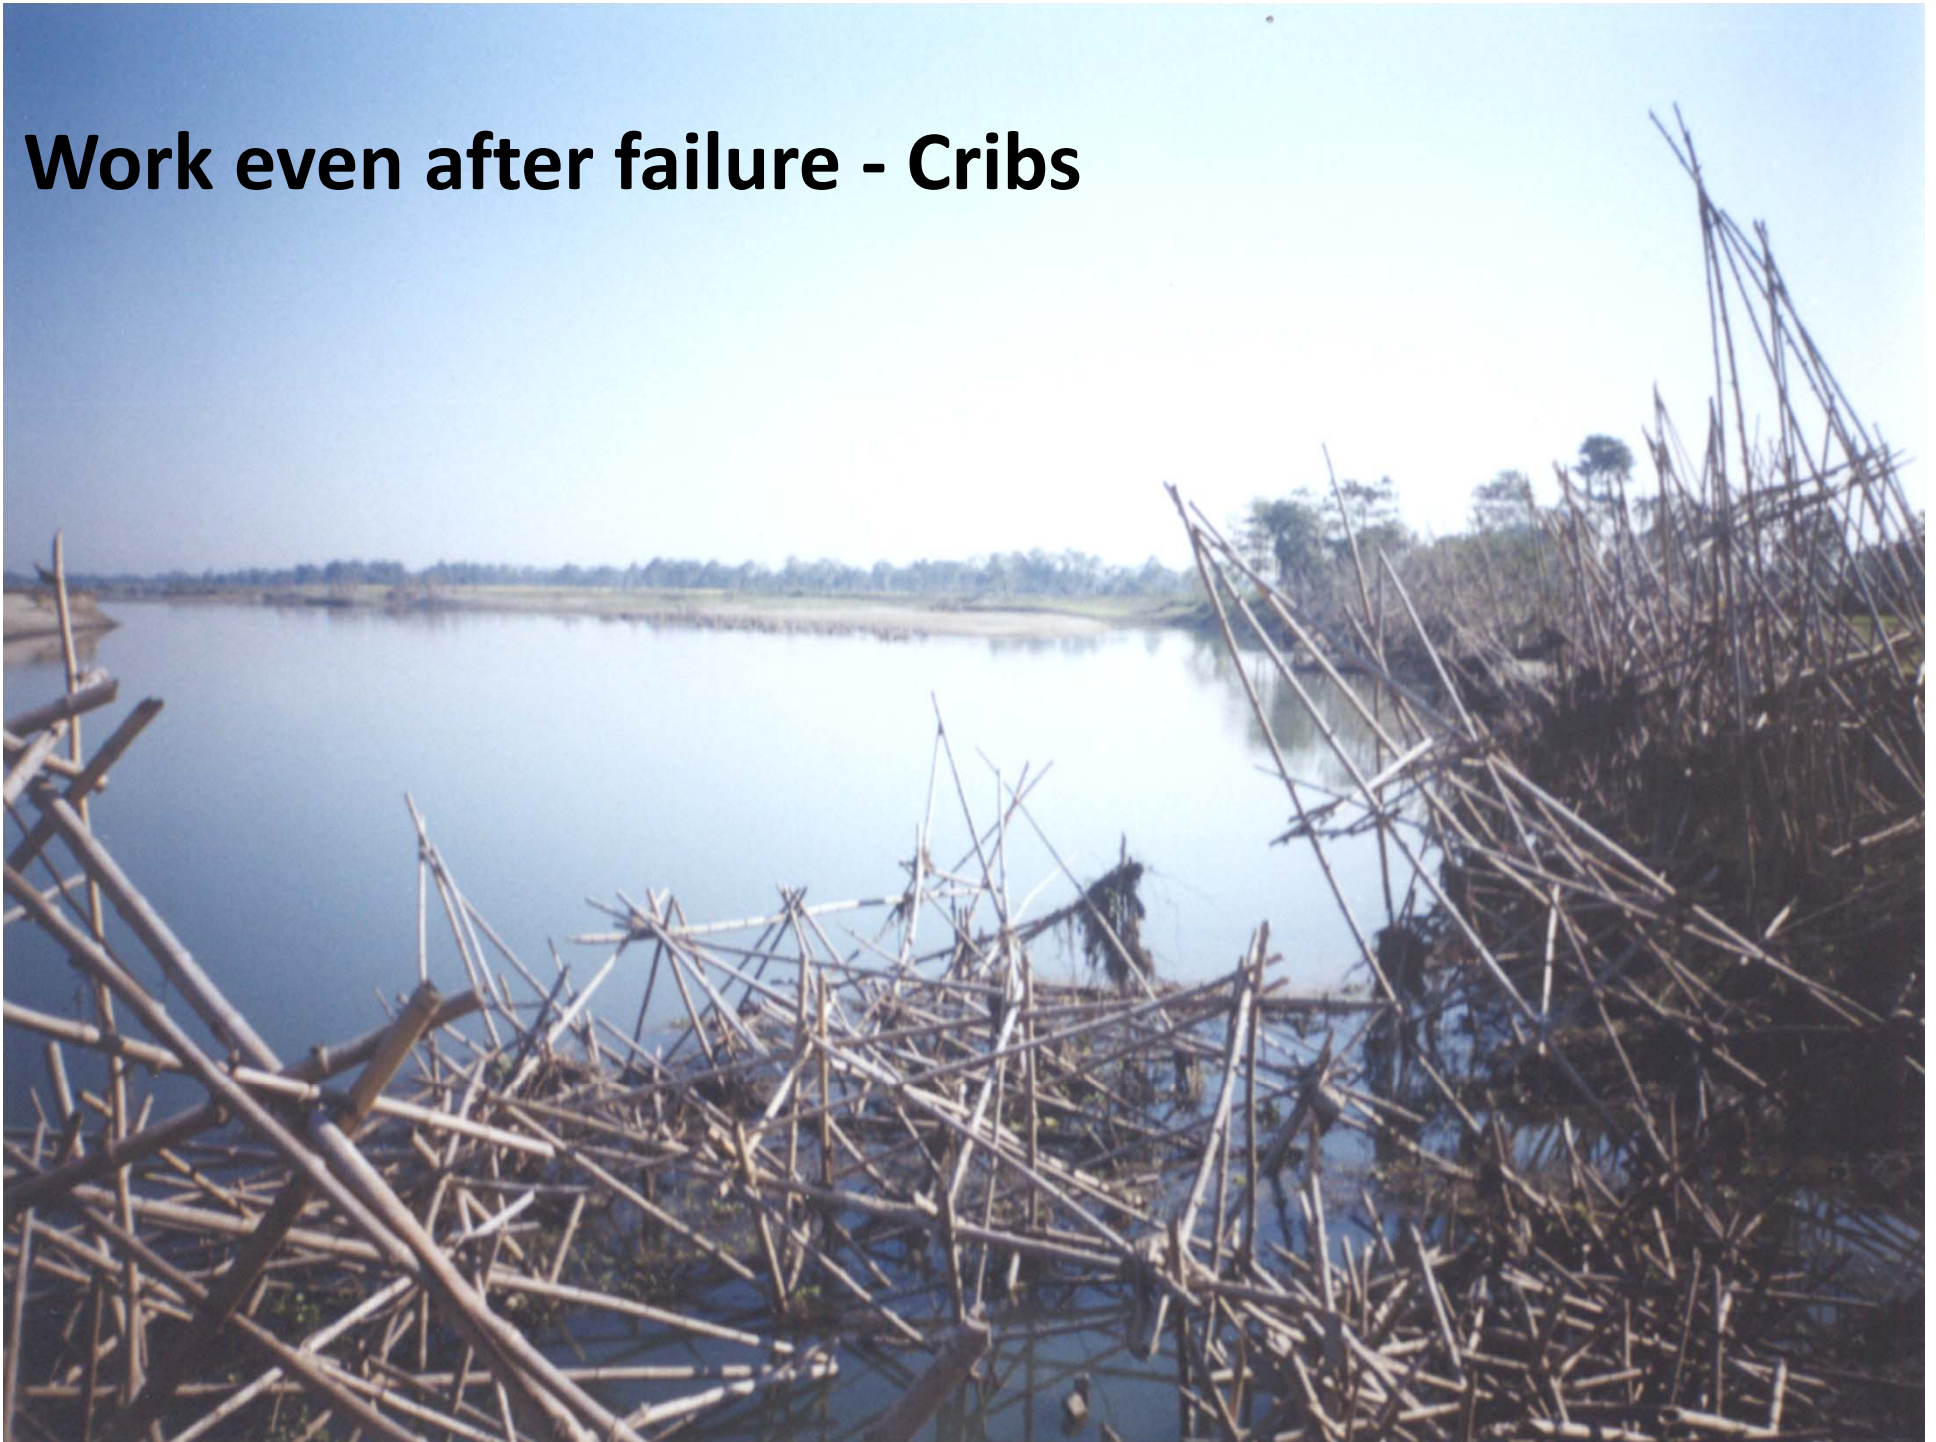
## Work even after failure - Cribs

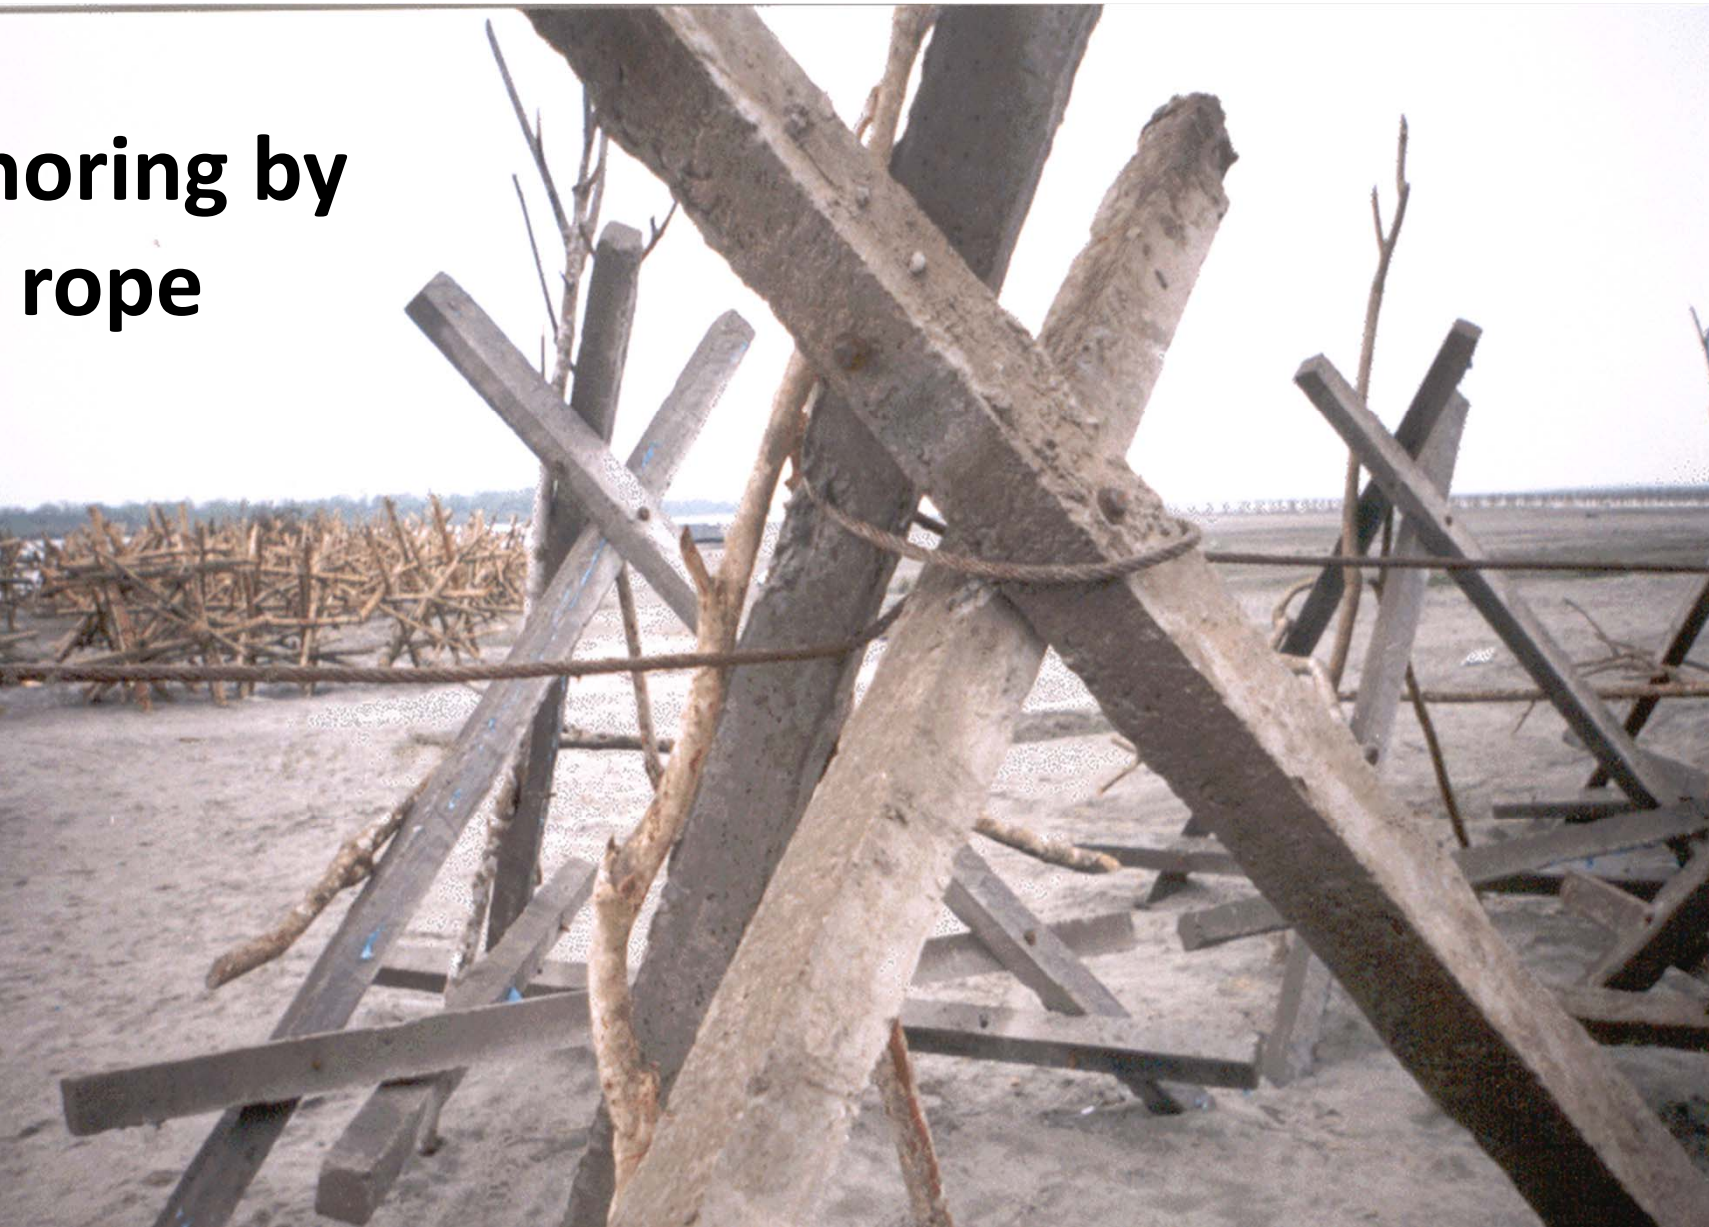
**RCC Porcupines in**

**mooring by  
rope**

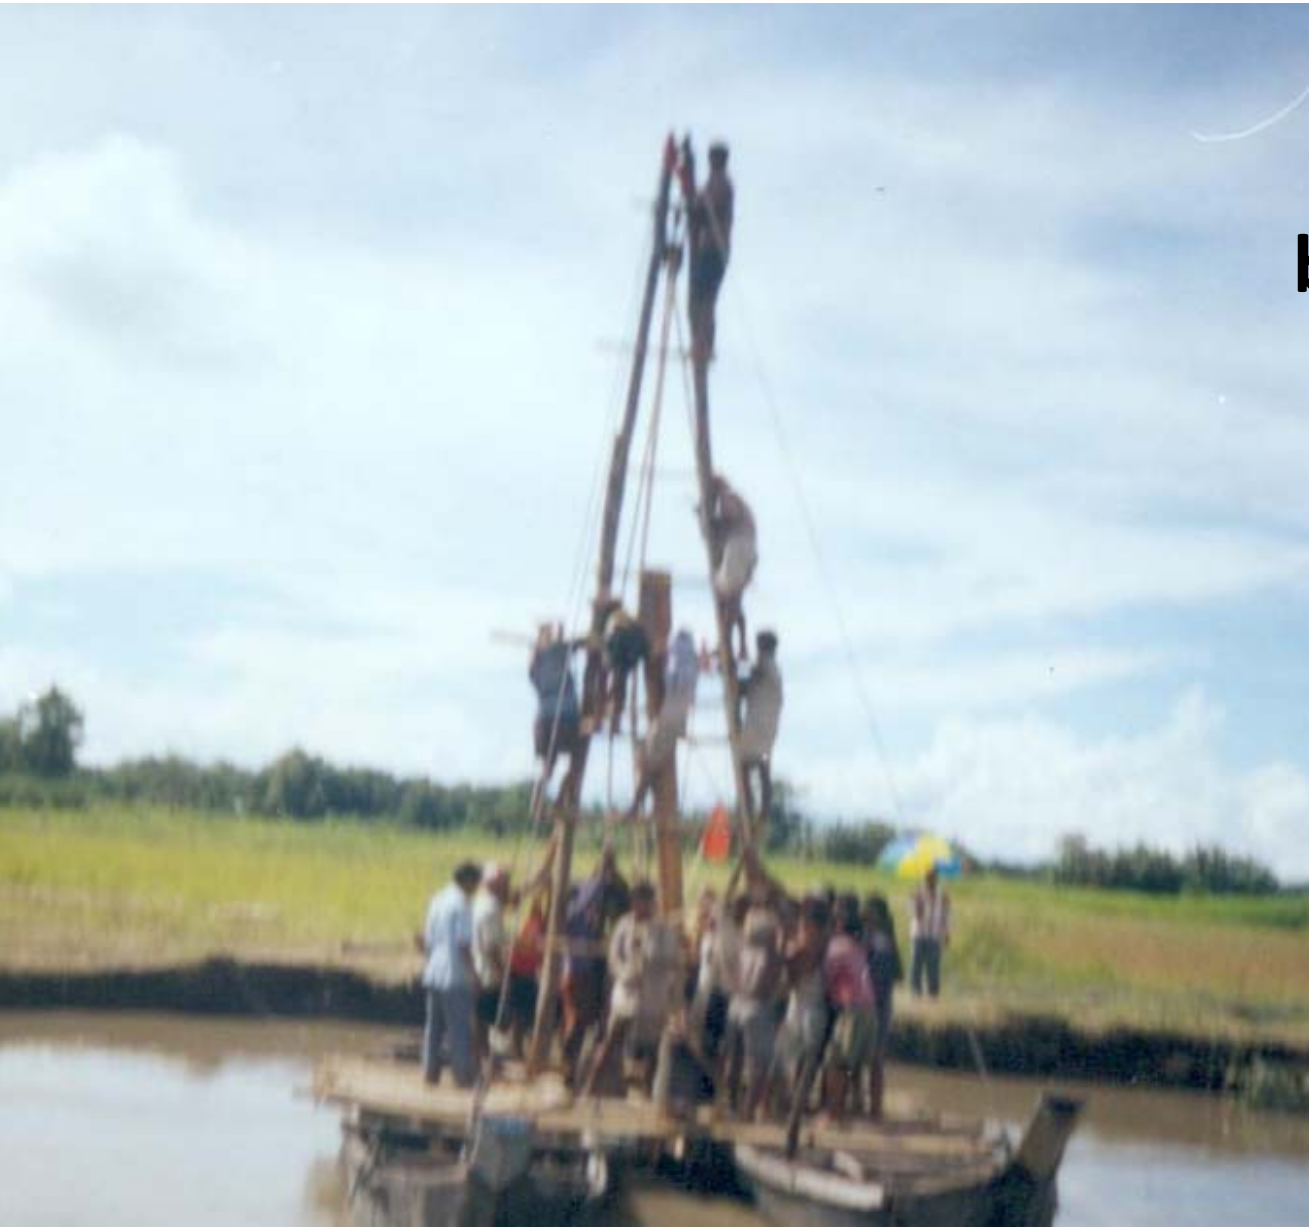
**Erecting  
gantry for  
bally pile  
driving at  
desired  
location**
