**Govt. of Assam**  
**WATER RESOURCES DEPARTMENT**

# **Good Practices in Dealing with River Bank Erosion Problems in Assam**

**Presented by :-**  
**Dr. R. K. Goswami, Water Resources Department, Assam**

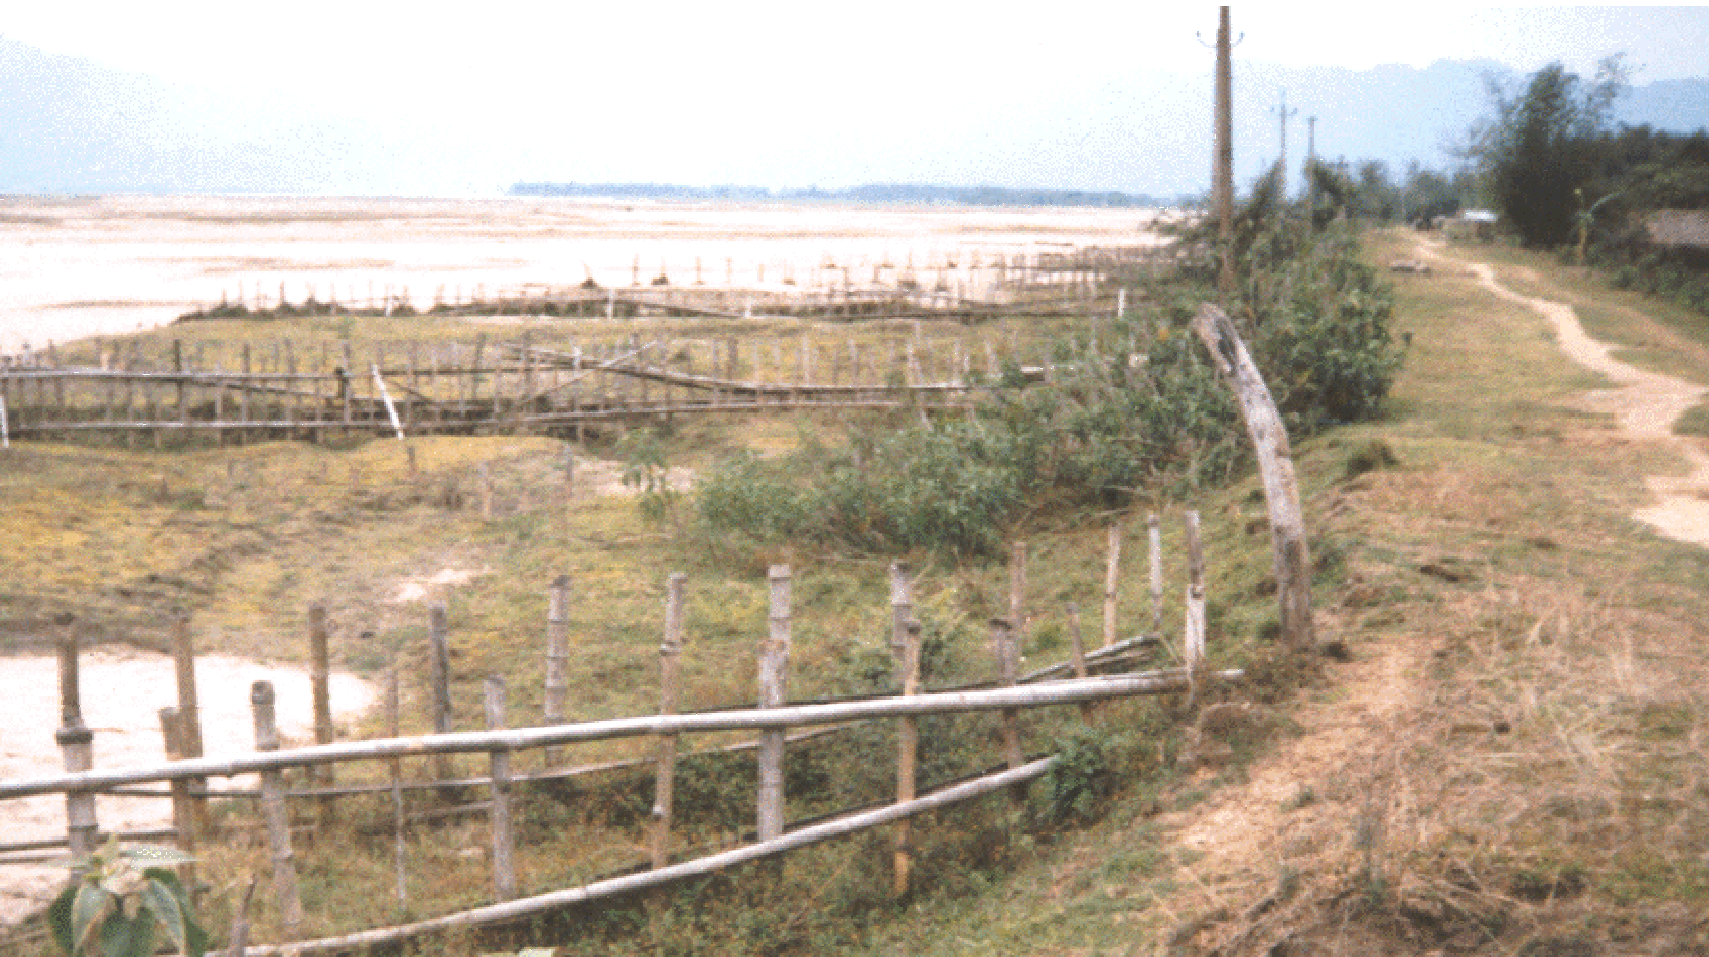
Function served : Dampening

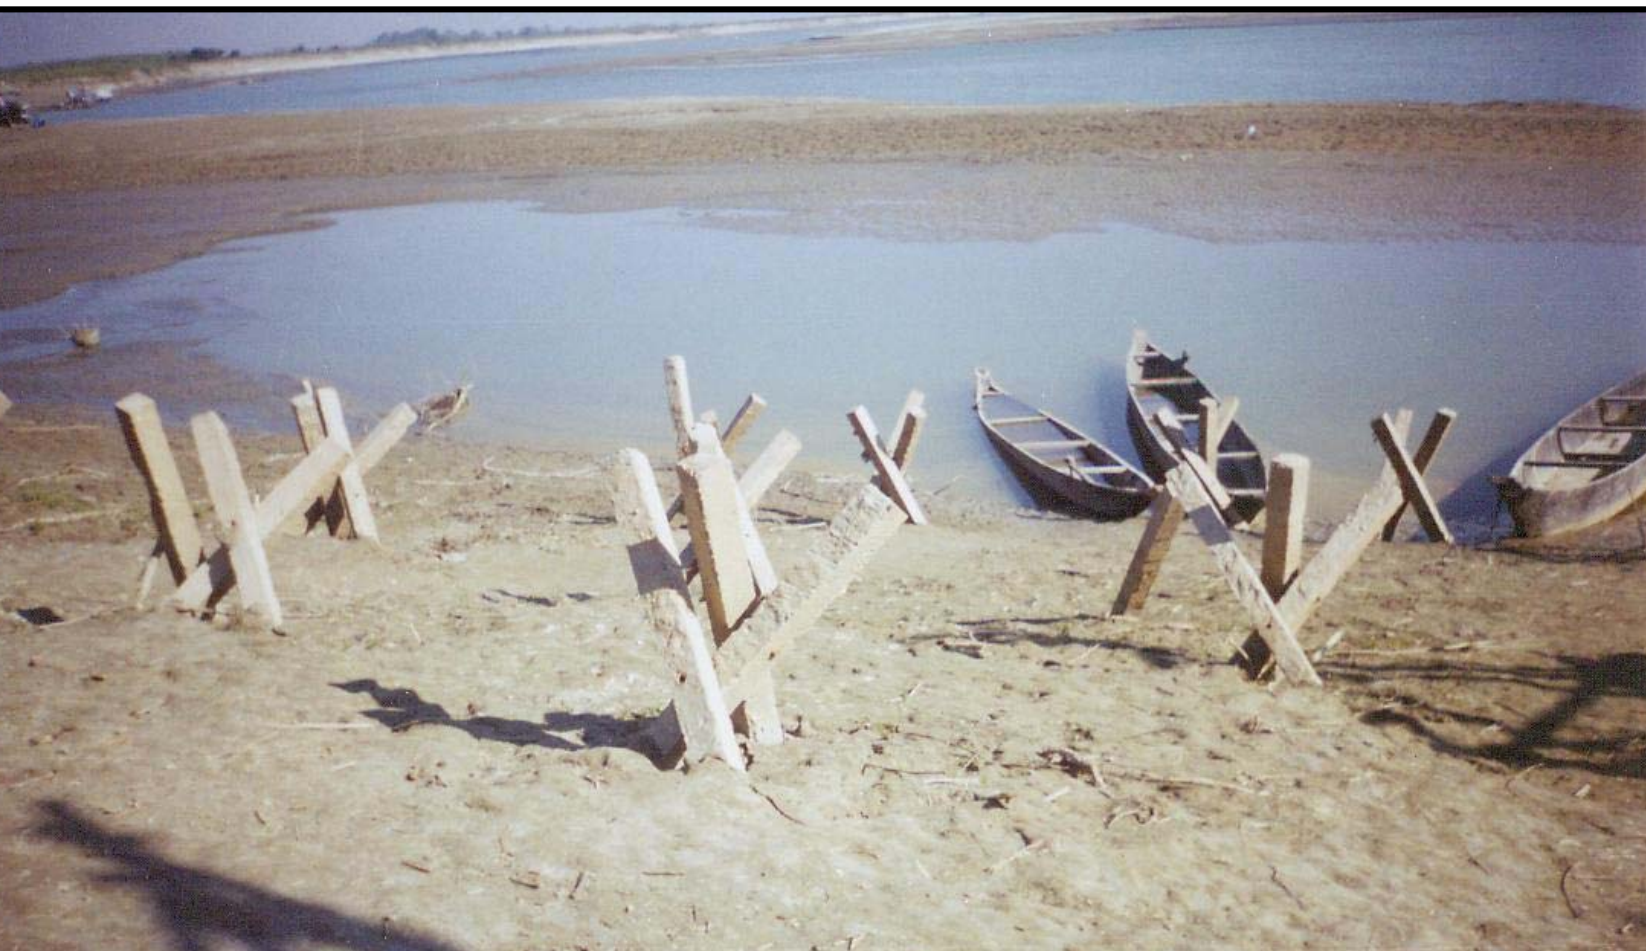
Function served : Sedimenting

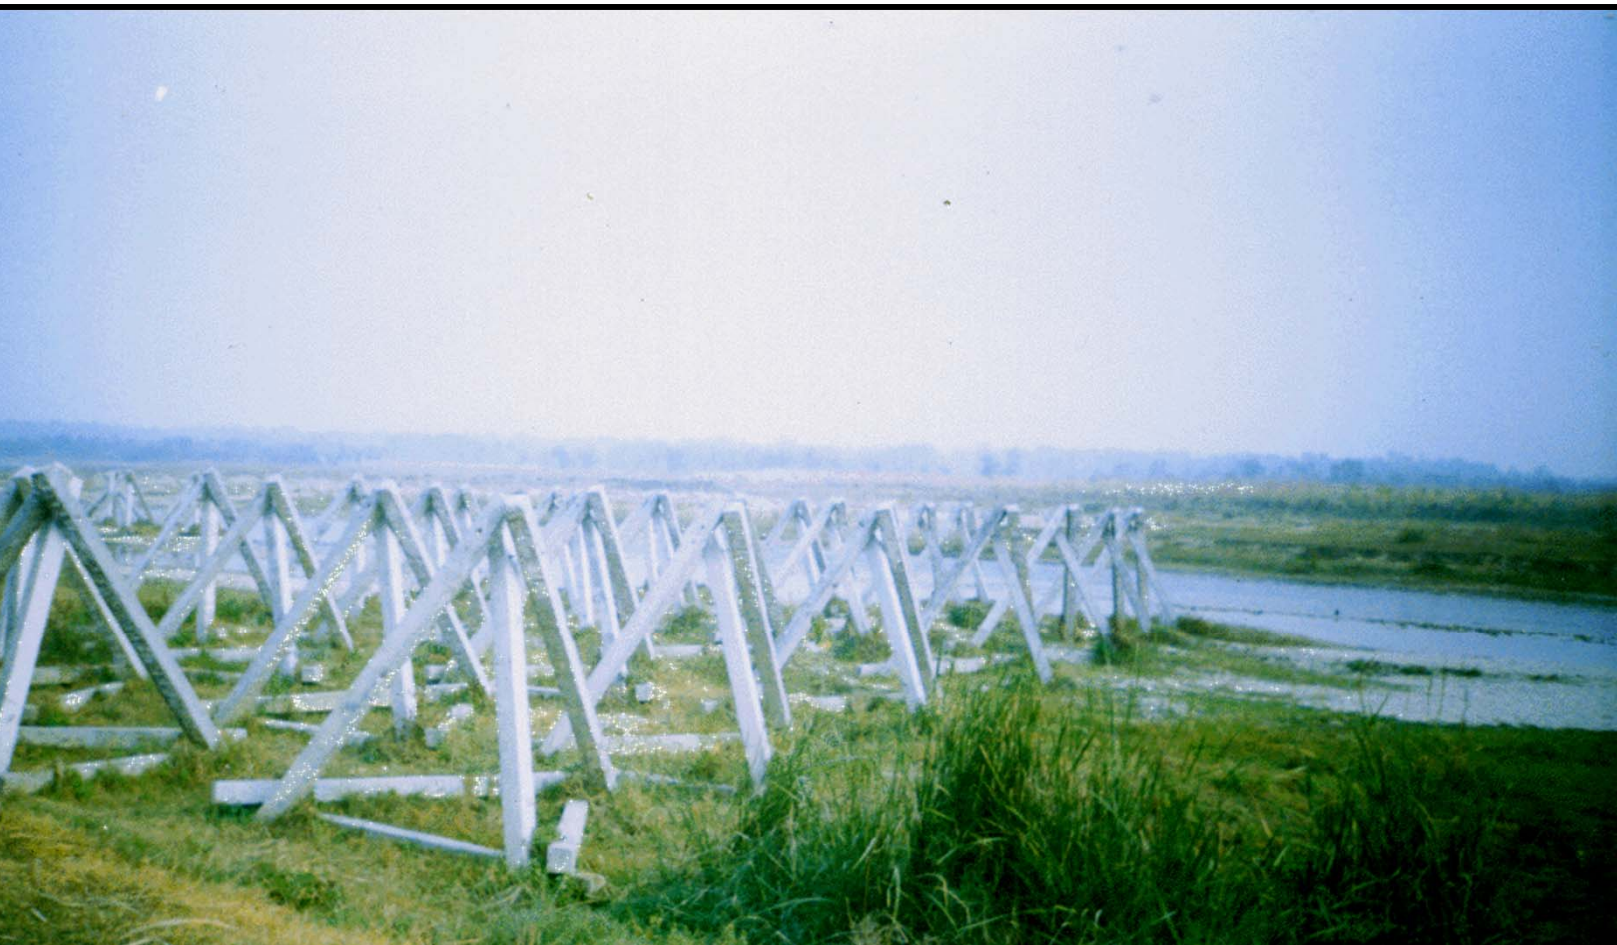
Function served : Diverting

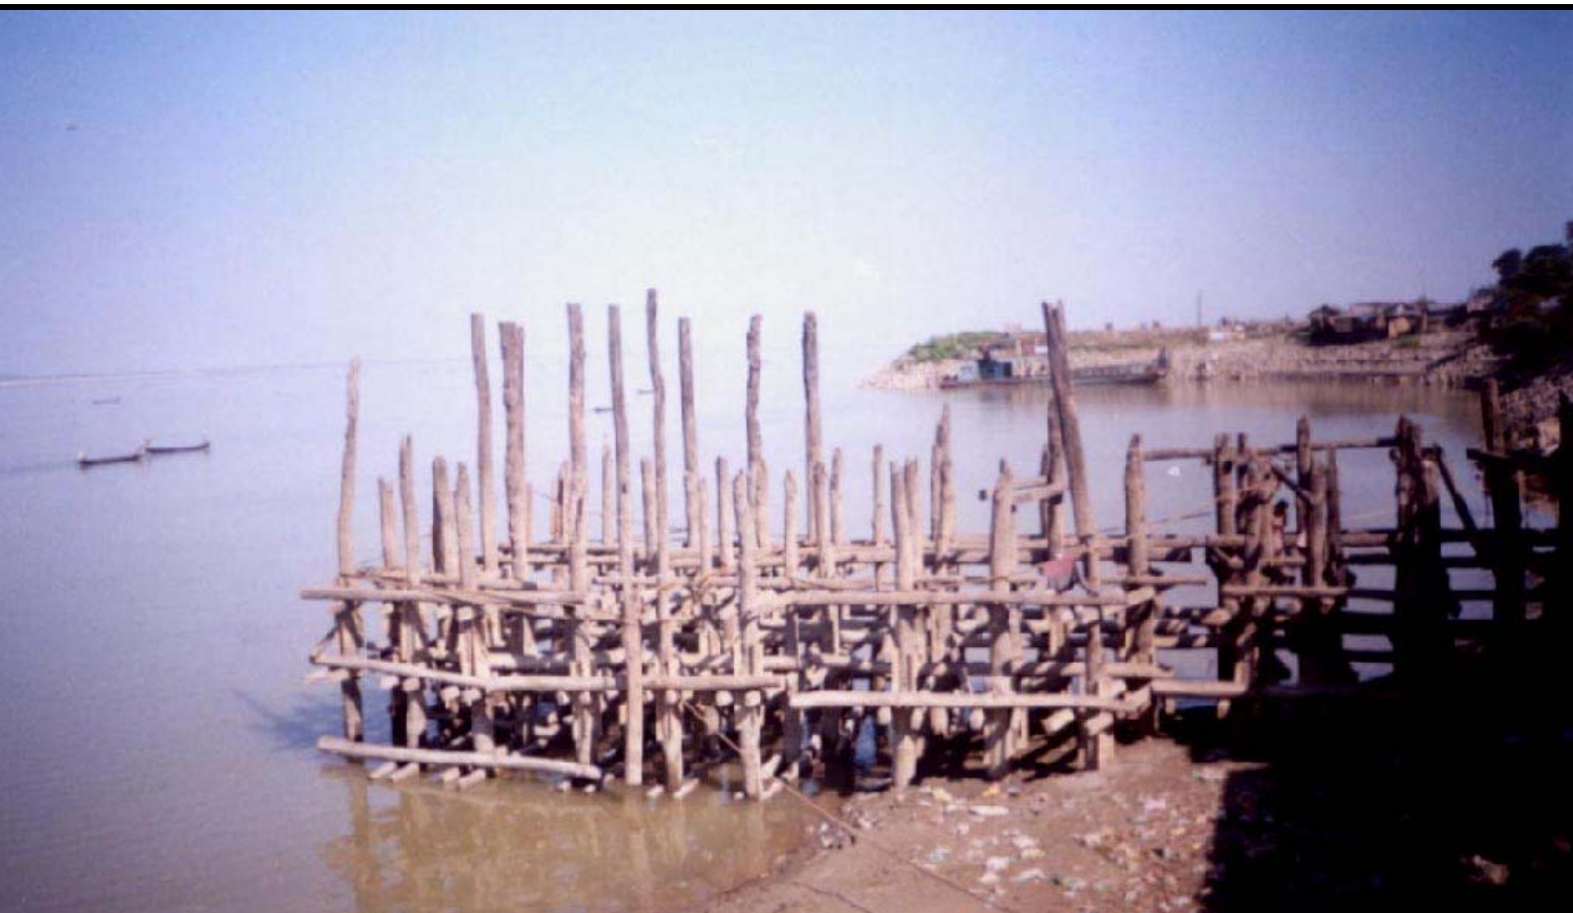
Construct. material : Bamboo, Ballies

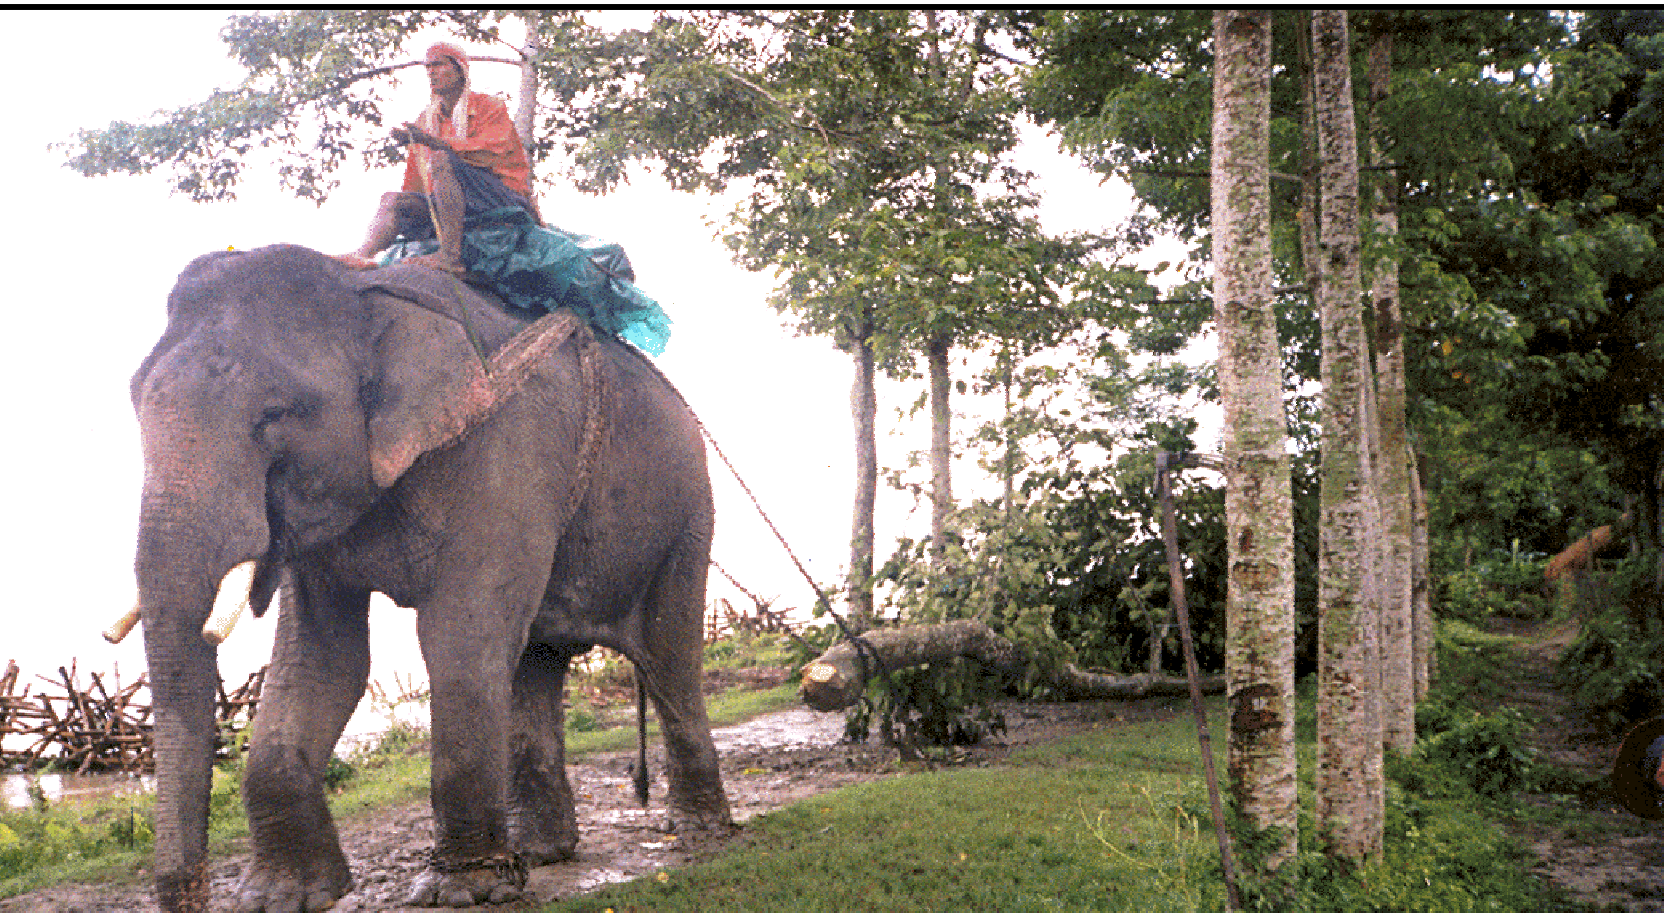
Construct. Material : Tree Branches
